# THE MYSTERIOUS CASE OF THE LEVITATING XENON: THE SEQUEL

Shaun Alsum

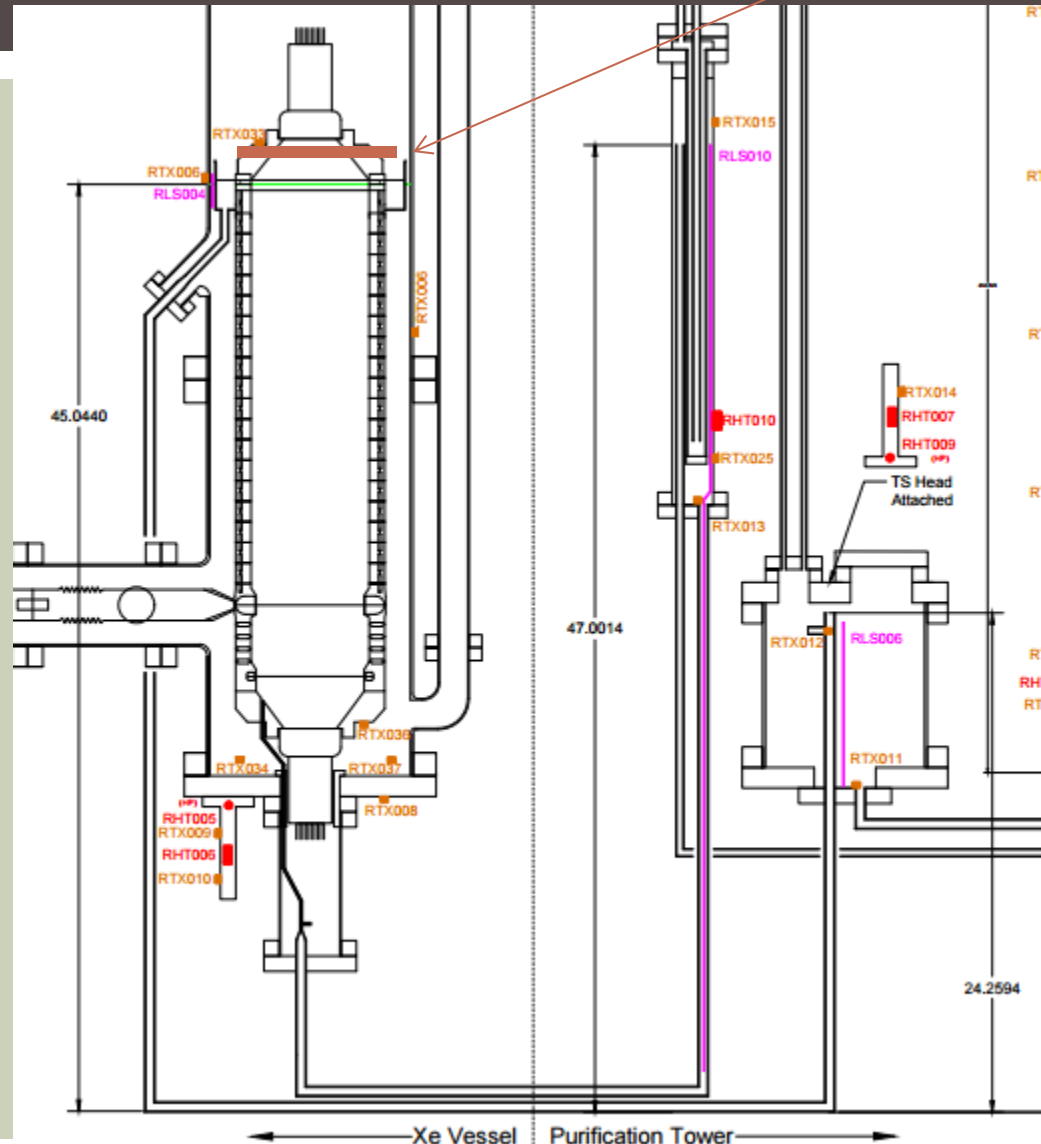
Liquid sits  
somewhere  
up here

Xenon does not reliably flow through the weir to the reservoir. Instead it often sits at a level above the weir.

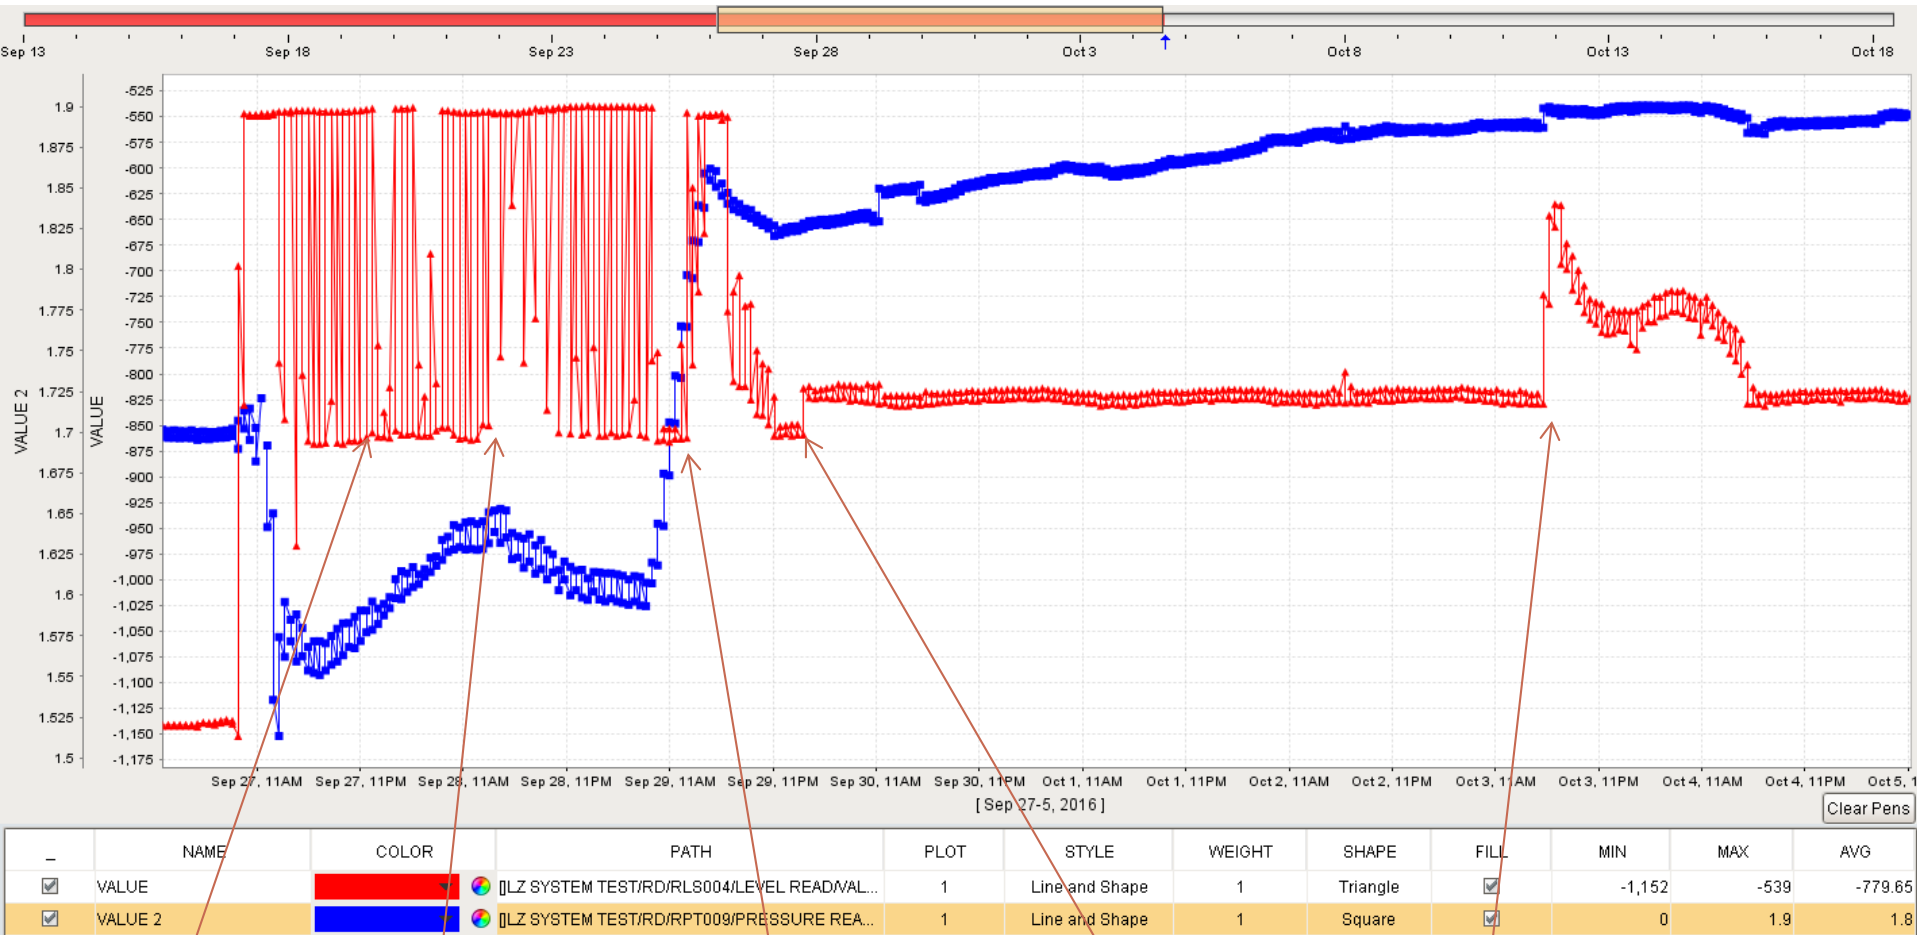
**Water Ice  
Test**

**Dry Ice  
Test**

**Raised detector  
pressure**

**Change in LS  
calibration**

**Unexplained  
deviation**

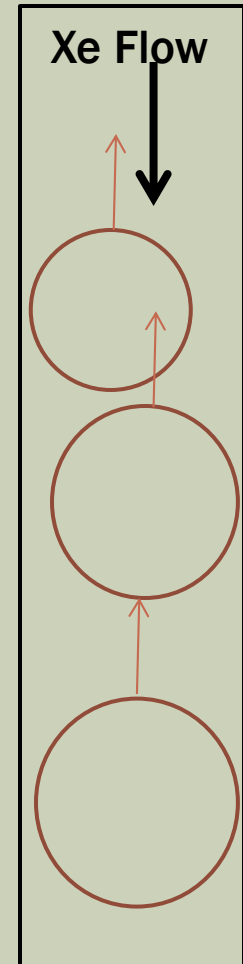
- Heat load on the outlet tube creates bubbles of Xe.
- Bubbles rise and impede flow.
- Cooling was not sufficient to reduce heatload, but pressure increase may decrease bubble size, less significantly impeding flow.
