# GAS TEST ANODE

*Rachel Mannino*  
*6 February 2018*

# INTRODUCTION: GAS TEST GRID HISTORY

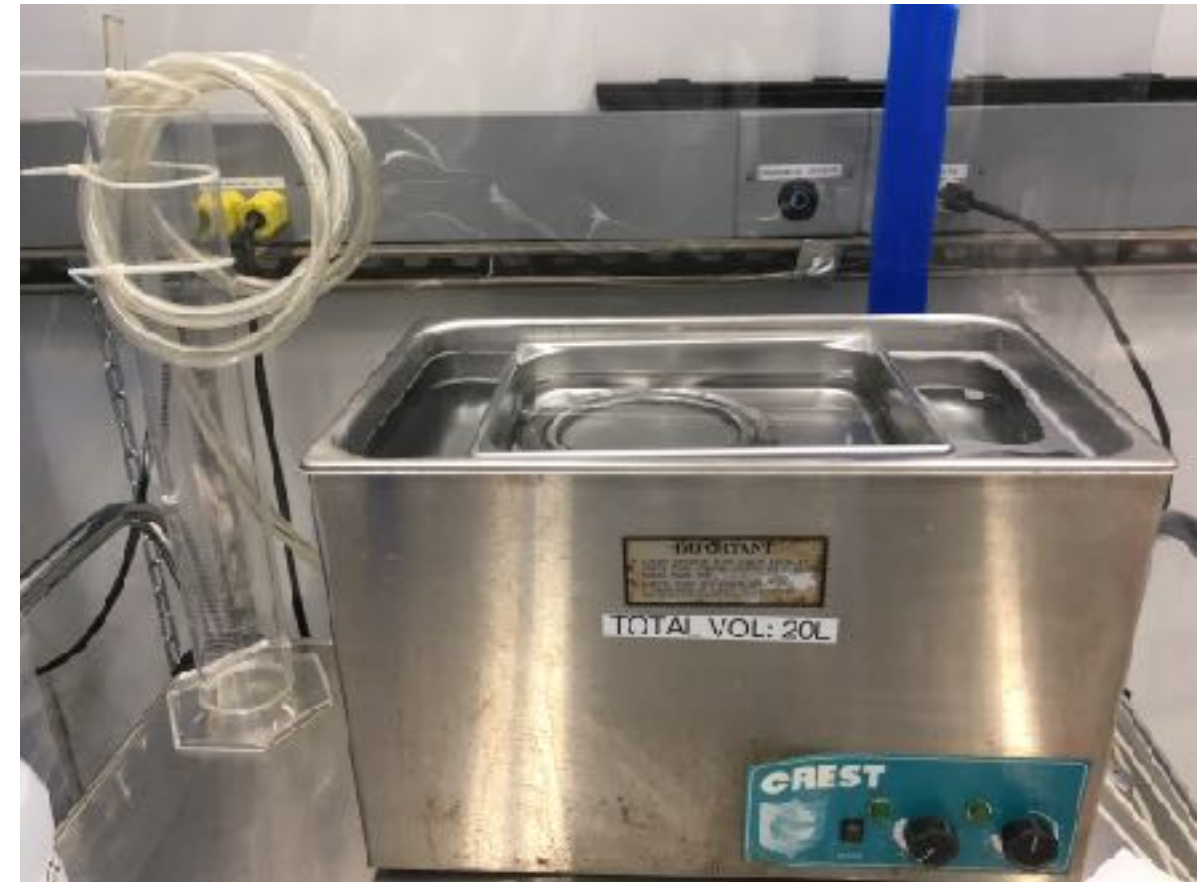
*Figure: Anode grid is placed in a tray within the ultrasonic cleaner in the cleanroom. DI water added to the tray spills over into the main bath visibly removing some debris from the water surface. Grid is removed from the tray once the surface is visibly clear.*

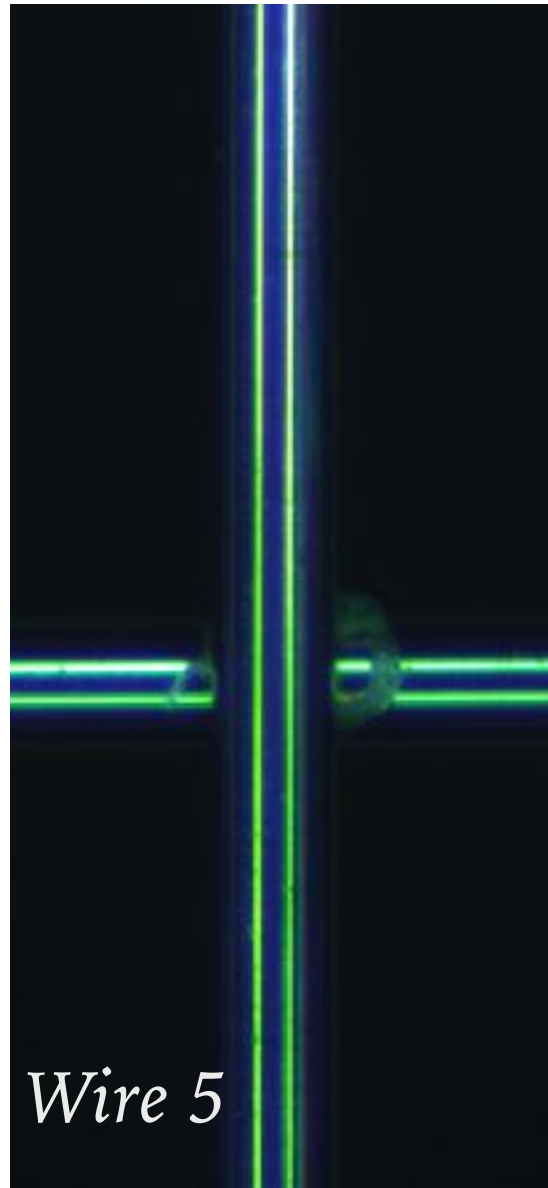
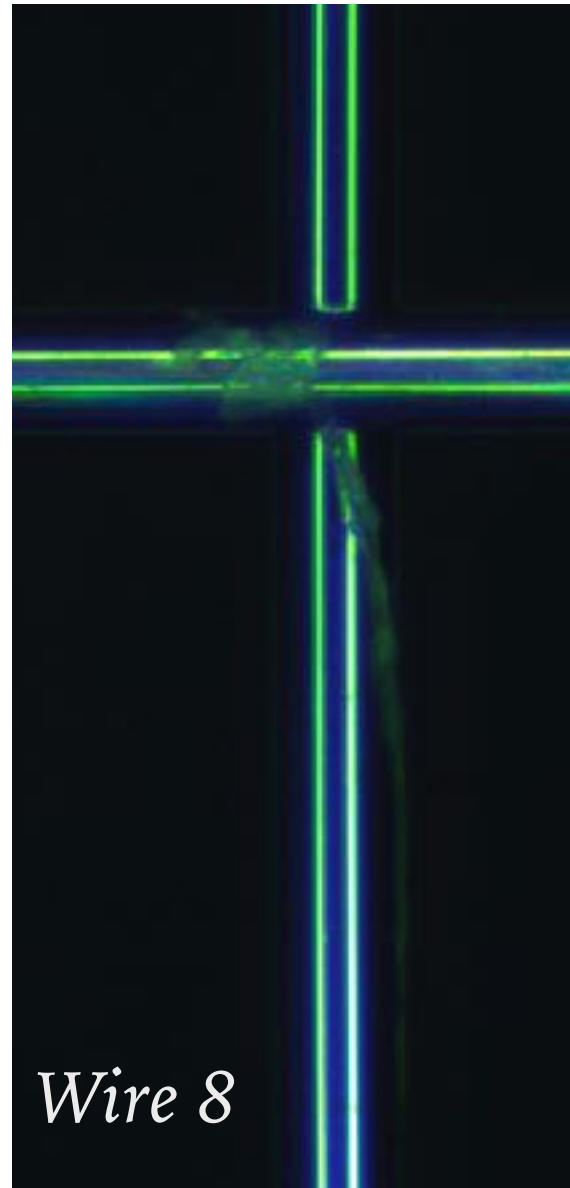
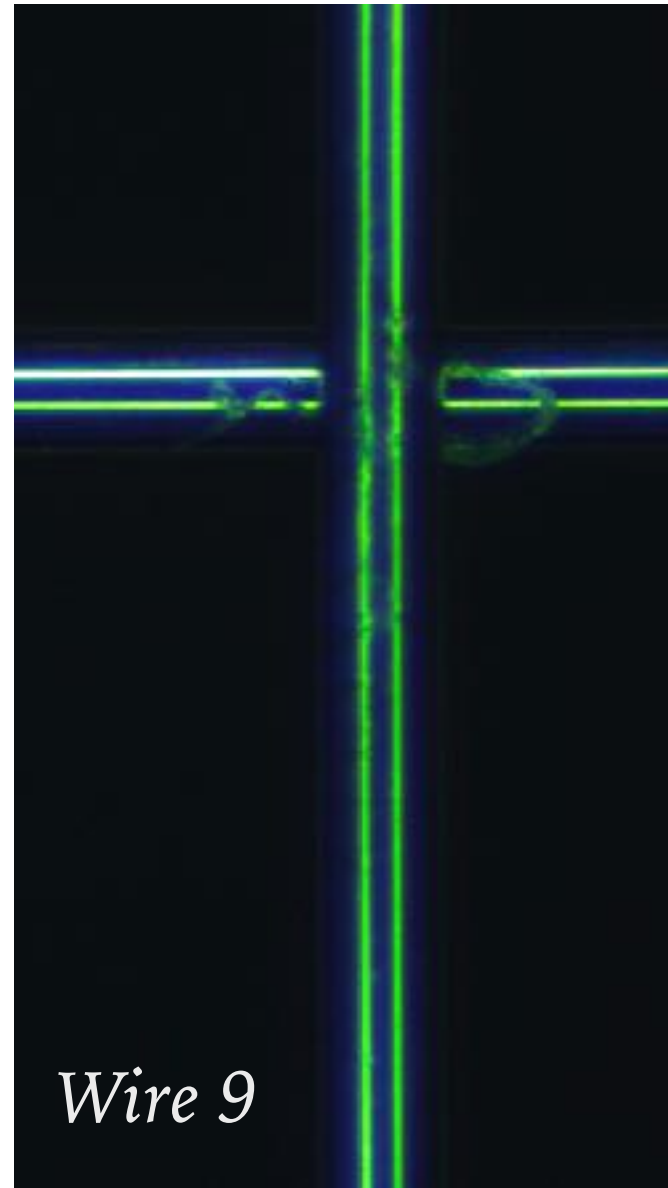
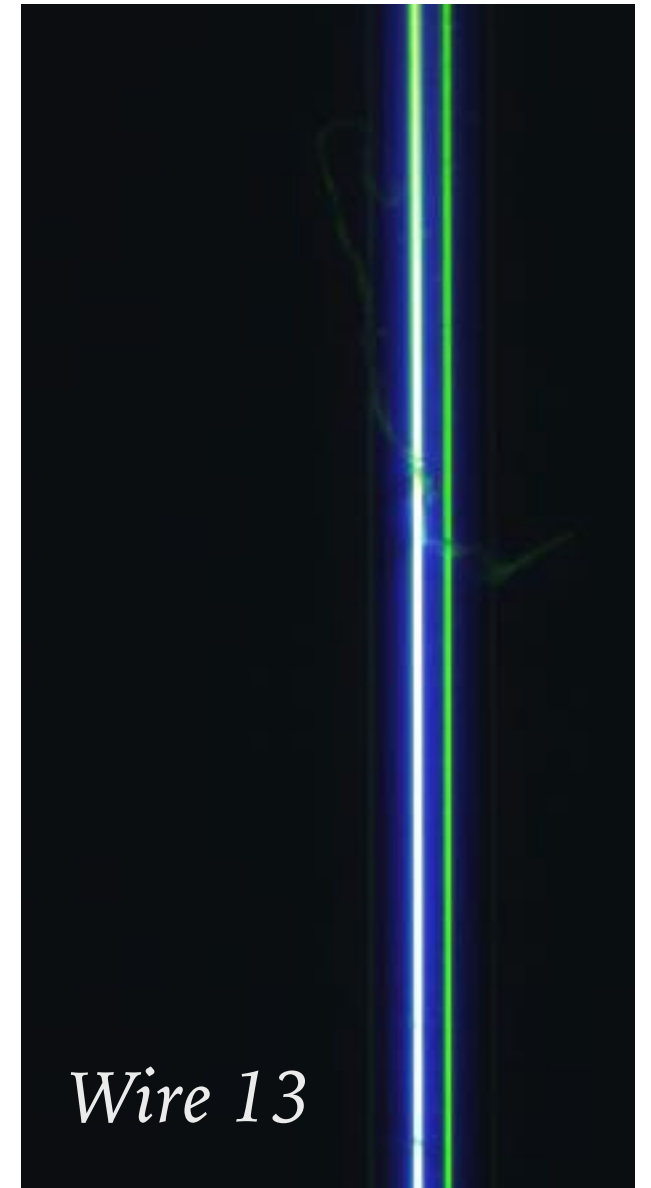
# BEFORE CLEANING: FIBERS

- 14 fibers observed on 20 wires (9 observed on wires 1-14).

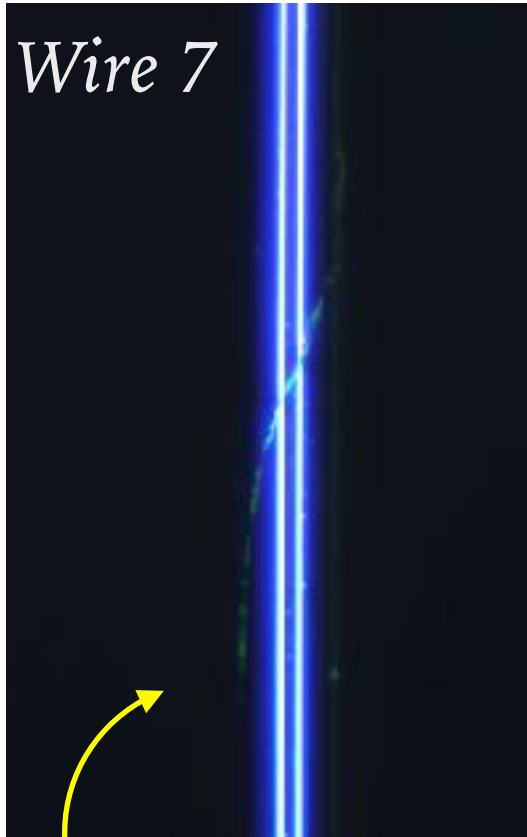
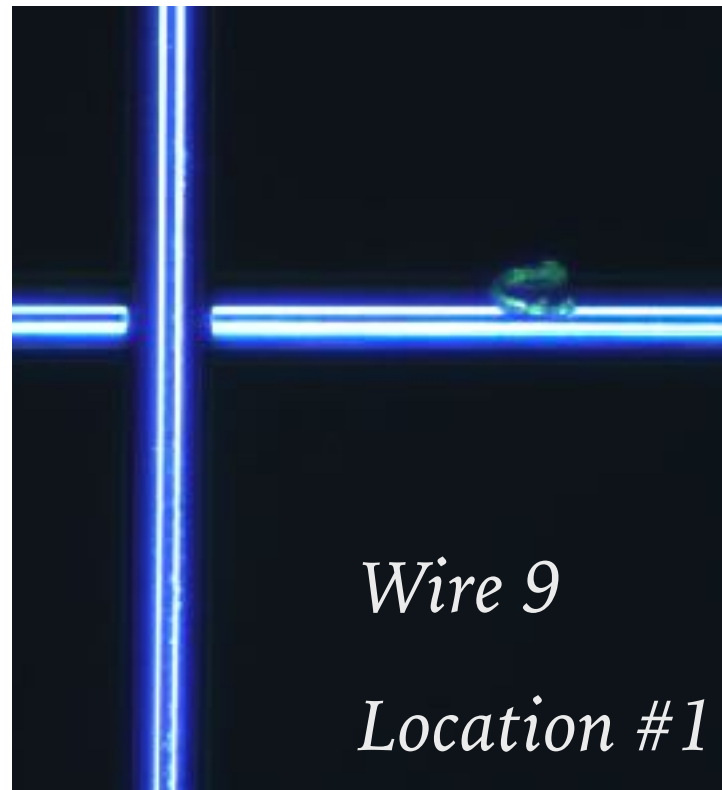
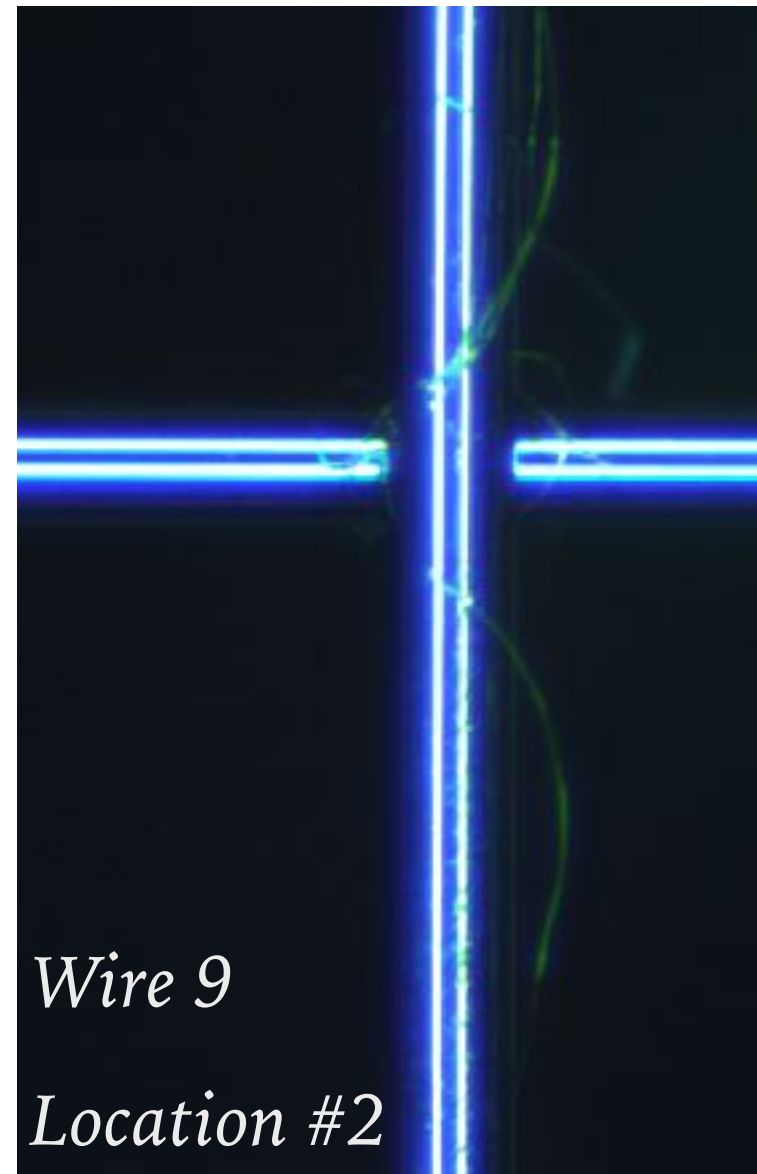
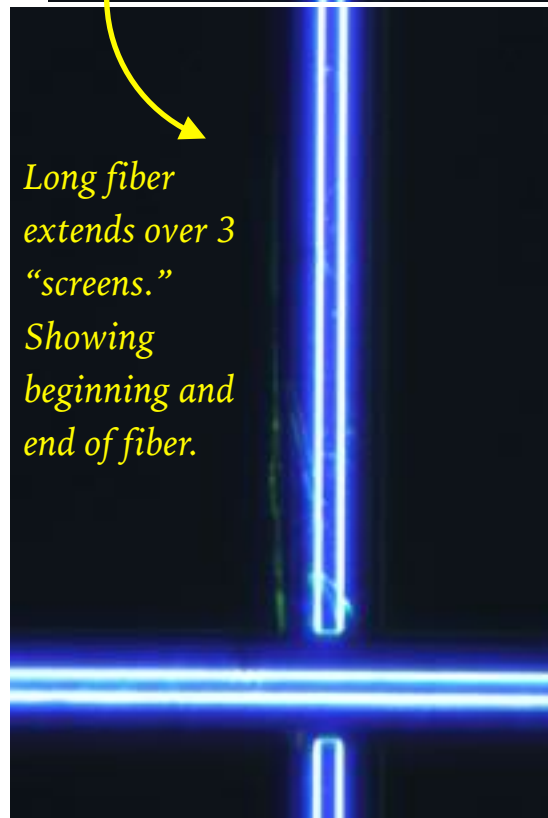
# AFTER CLEANING: FIBERS

- 3 fibers seen in wires 1-14.

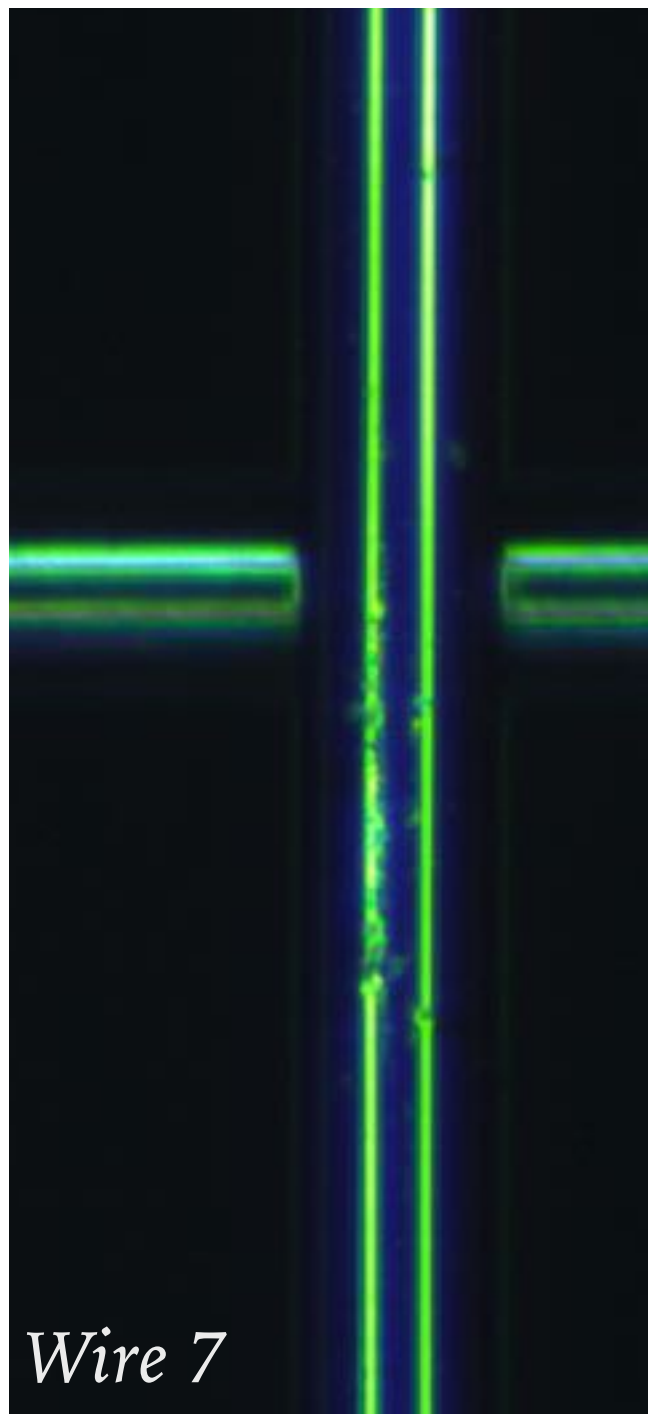
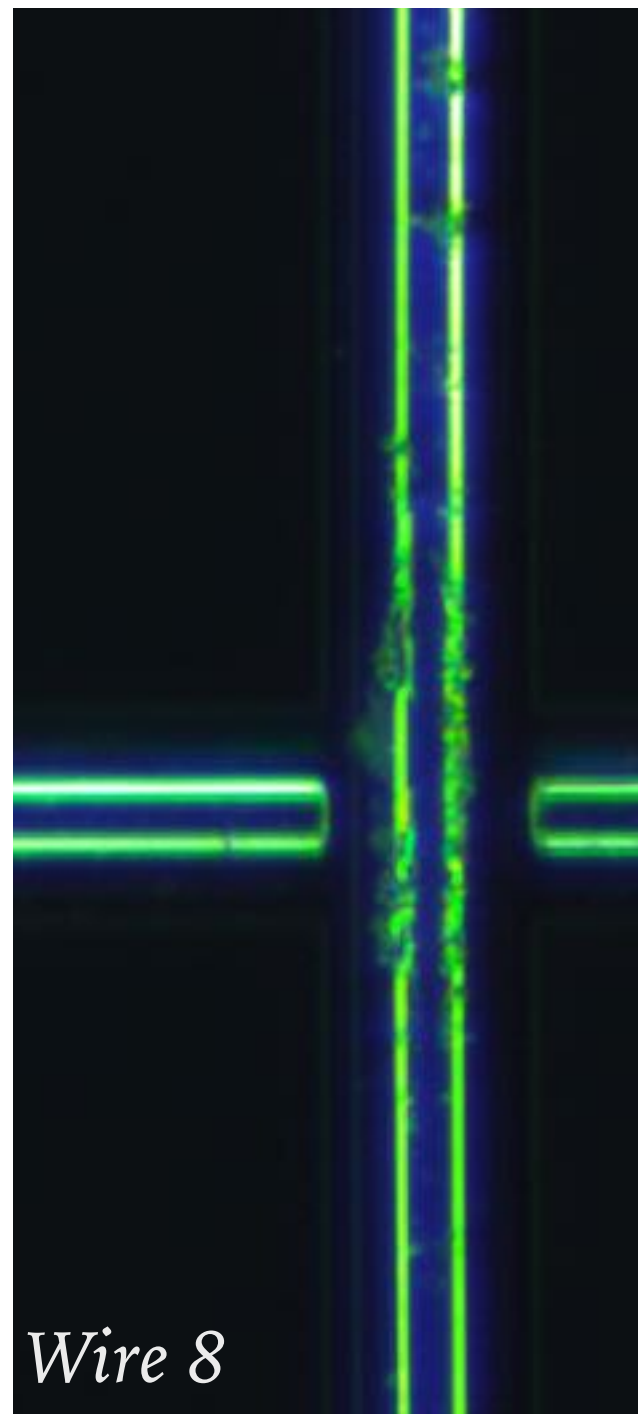
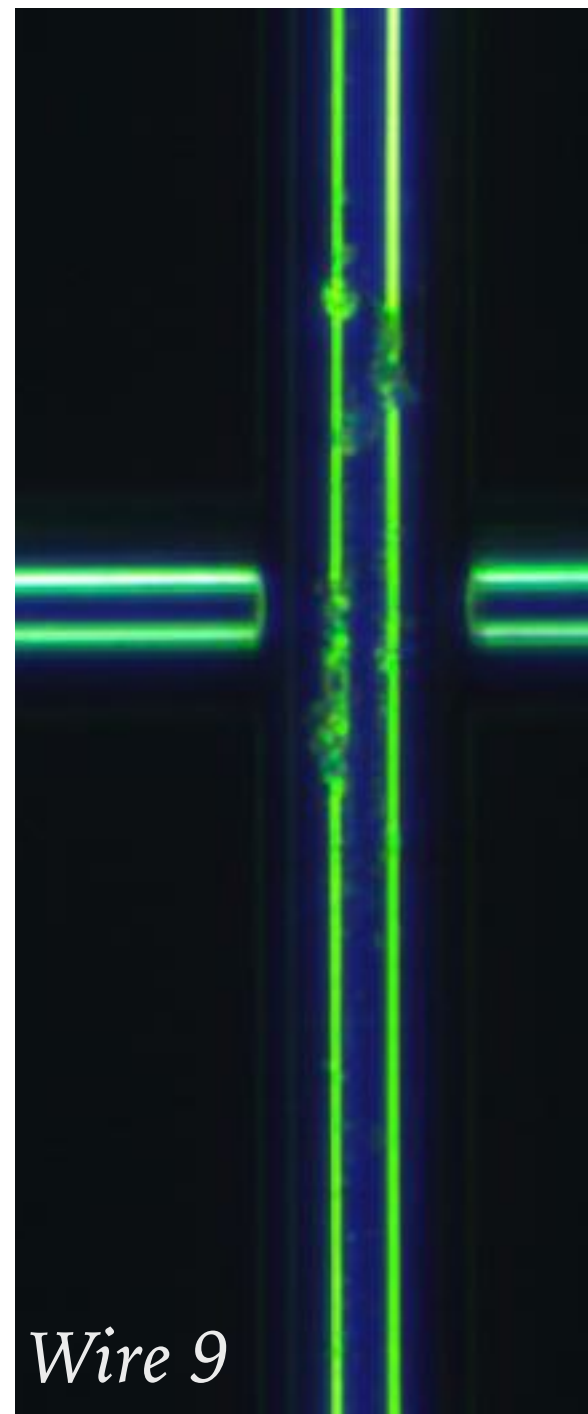
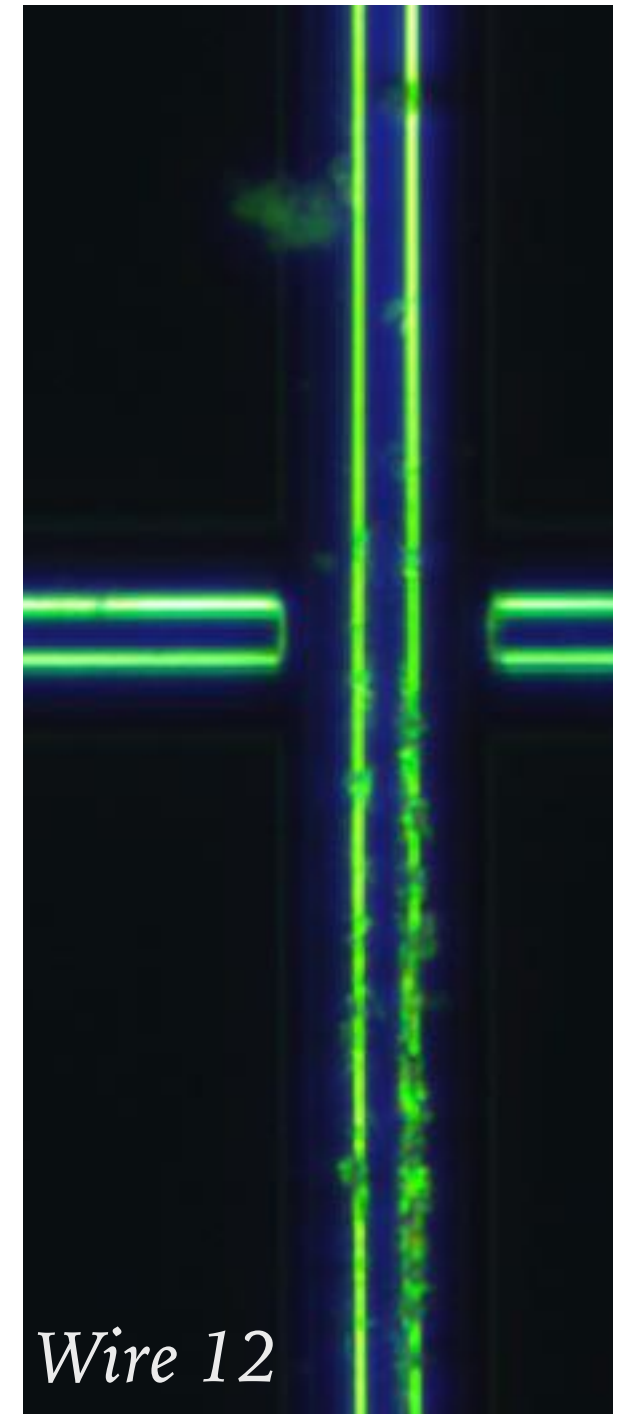
# BEFORE CLEANING: CRUSTY REGION

- 92 crusty regions in wires 6-14

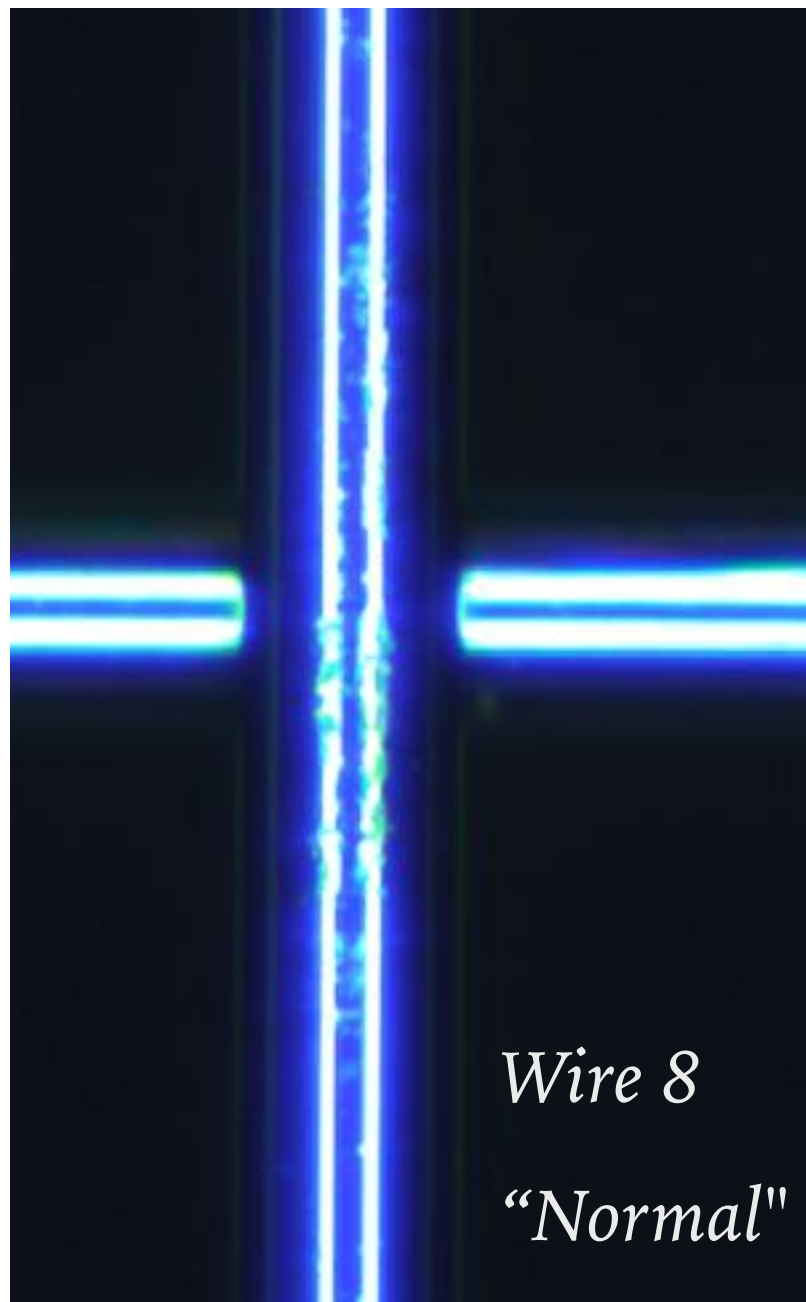
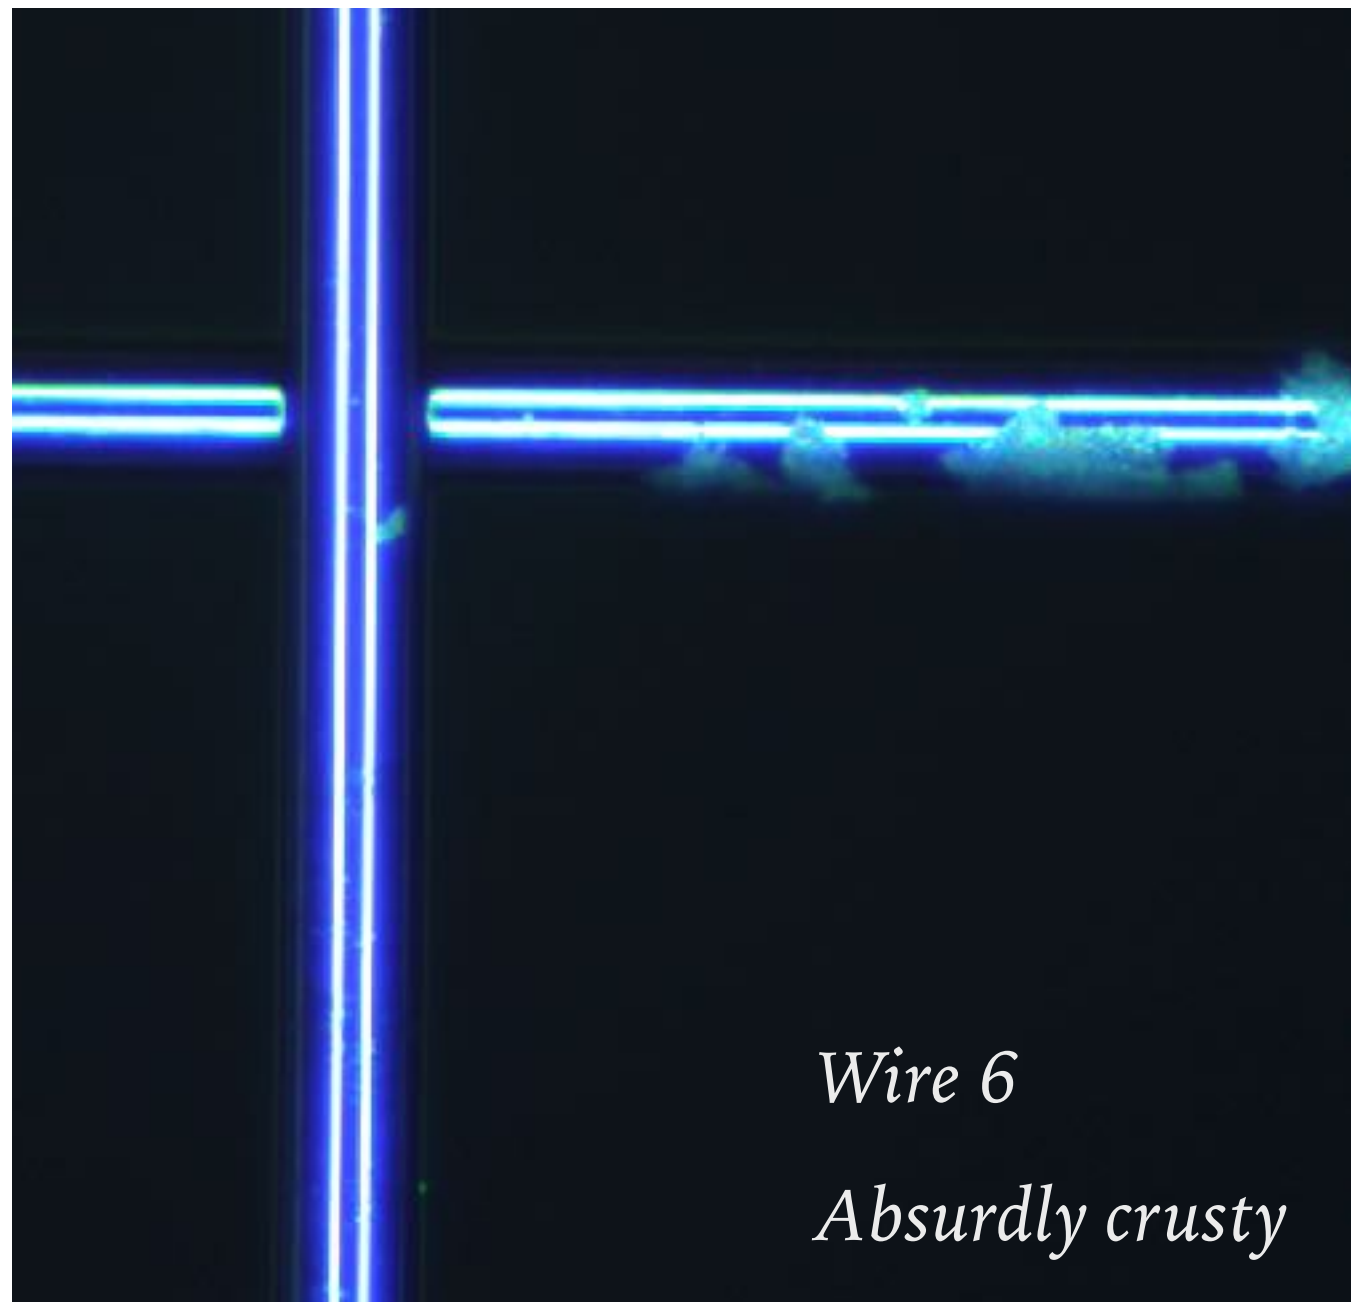
# AFTER CLEANING: CRUSTY REGION

- 83 crusty regions counted in wires 6-14.

- Advanced's passivation bath left debris, crust, fibers on the wires.
  - **Solution:** Passivate in a cleanroom environment at Astropak.
- Cleaning in an ultrasonic bath reduced the number of fibers on the wires, but had very little effect ( $\sim 10\%$  reduction) on the number of crusty regions.
- The location of crusty regions on only the intersections of the top surface of the wires indicates debris may have been deposited during the cleaning/handling process.
  - Not seen on the Phase I grids sent to Advanced. Maybe a different bath was used or someone previously using the bath left debris.
- **Plan:** Weave a new gas test gate grid and send to Astropak for passivation.
  - Expect less debris as grid will only see cleanroom environments.

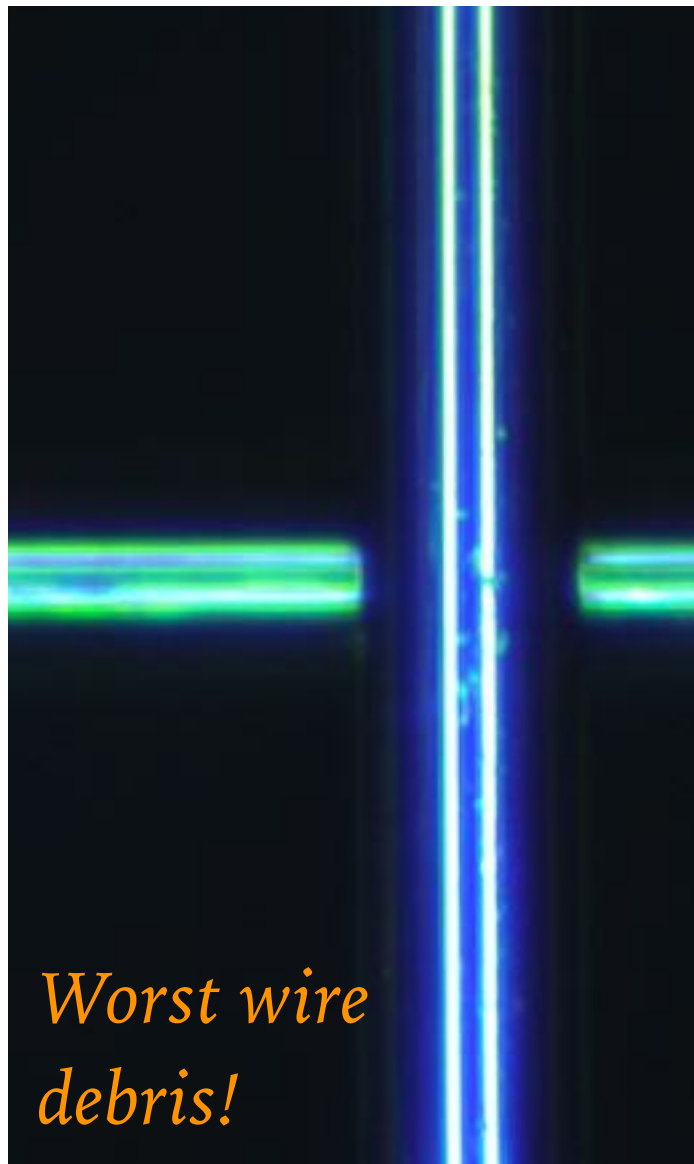
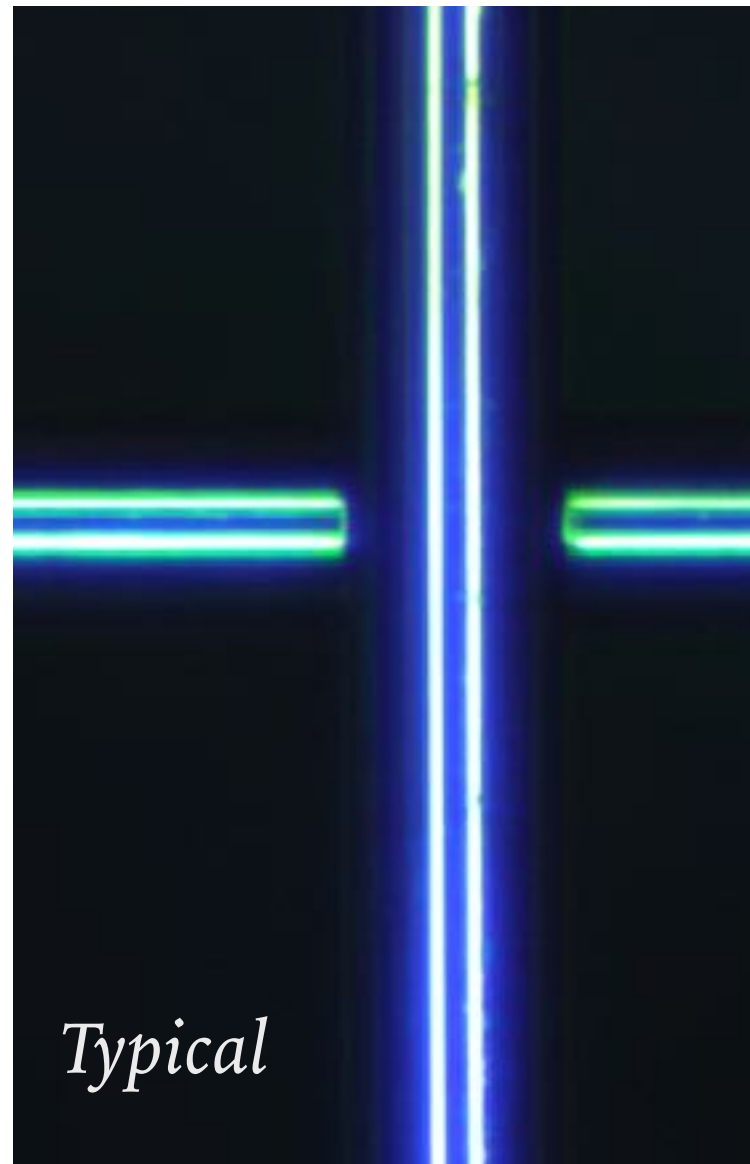
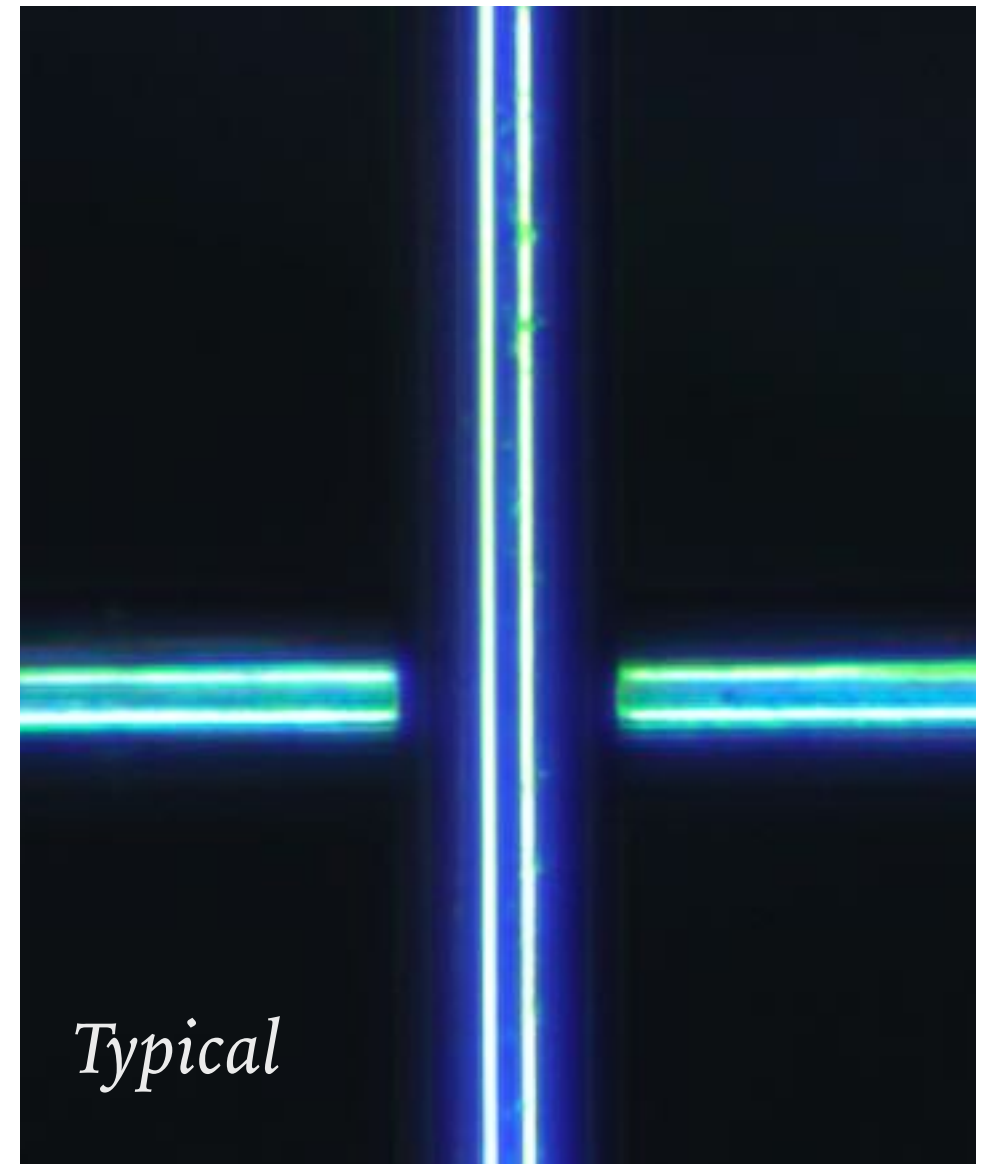
# AFTER CLEANING: CRUSTY REGION **ON UNDERSIDE OF WIRES**

- 104 intersections on 2 long wires —> no crust
- Grid was submerged in the passivation bath at Advanced *right-side up*.
  - Presumably lifting it out of the bath deposited debris on the top surface. The underside has remained mostly clean.

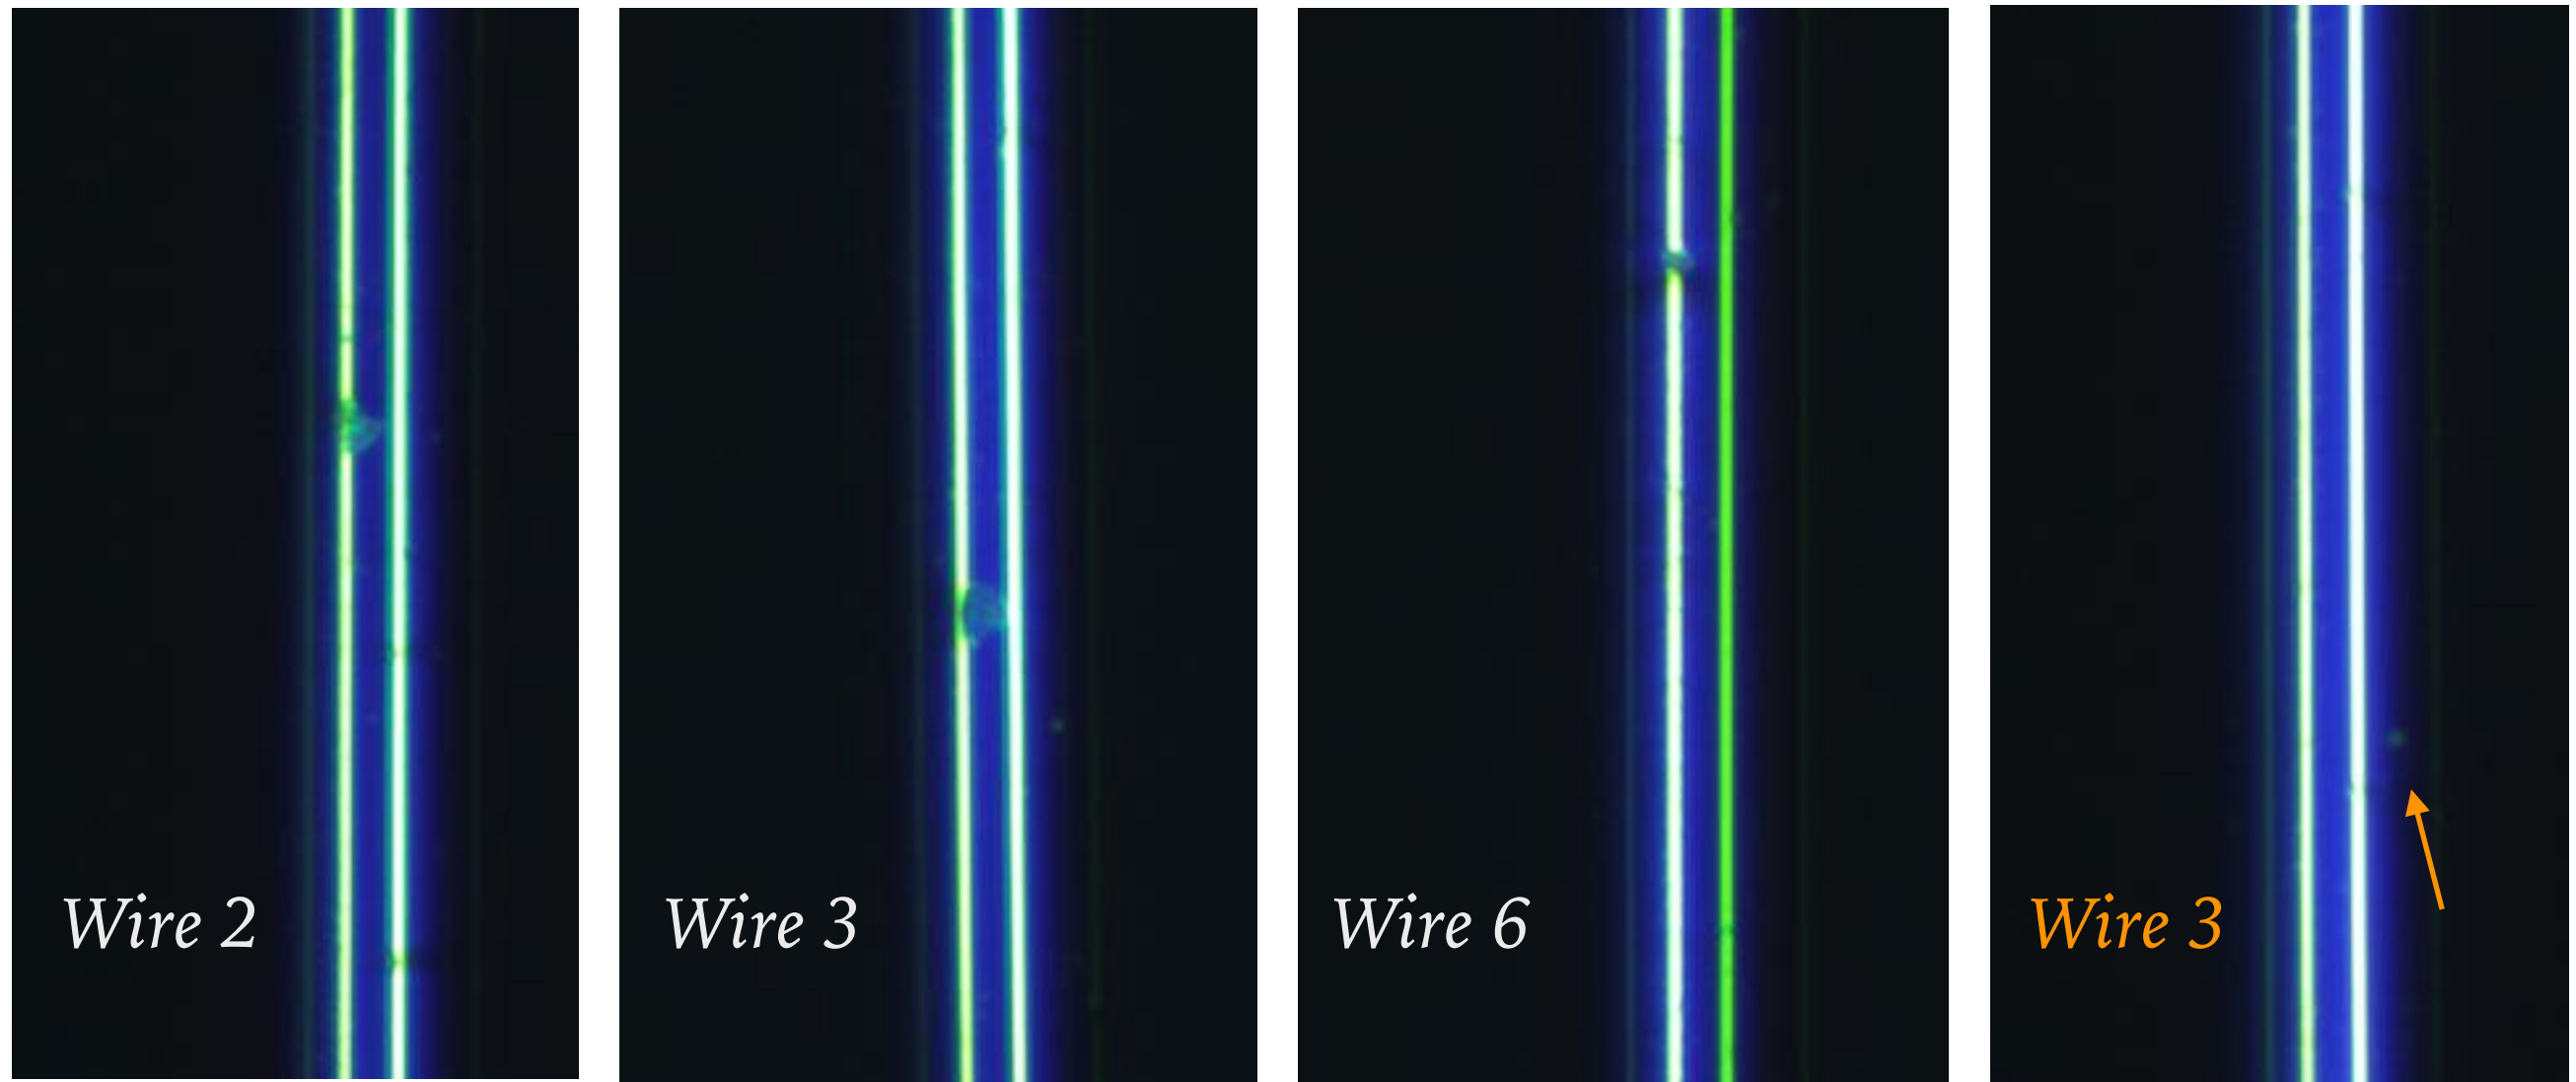
# BEFORE CLEANING: BLOBS

- Matter which looks separate from possible surface defects.
- Counting sizable objects.
  - Rightmost photo shows a “speck” which are not typically counted.
