PMT issues encountered at SLAC

Kimberly Palladino
March 12, 2016

New PMT: KB0095

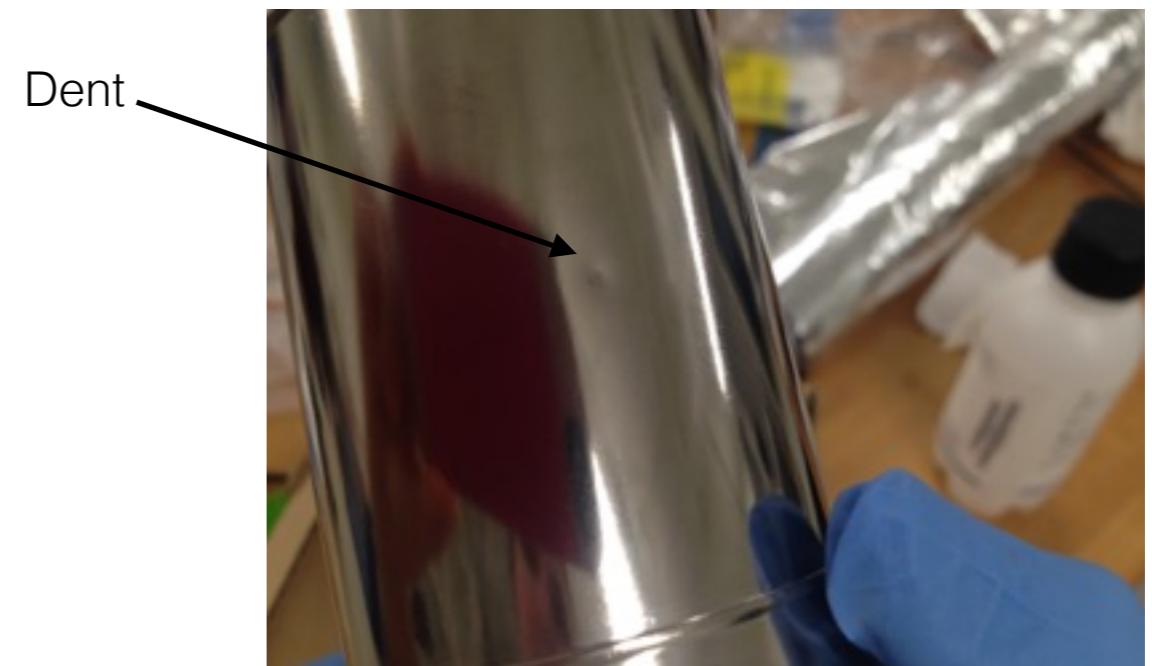
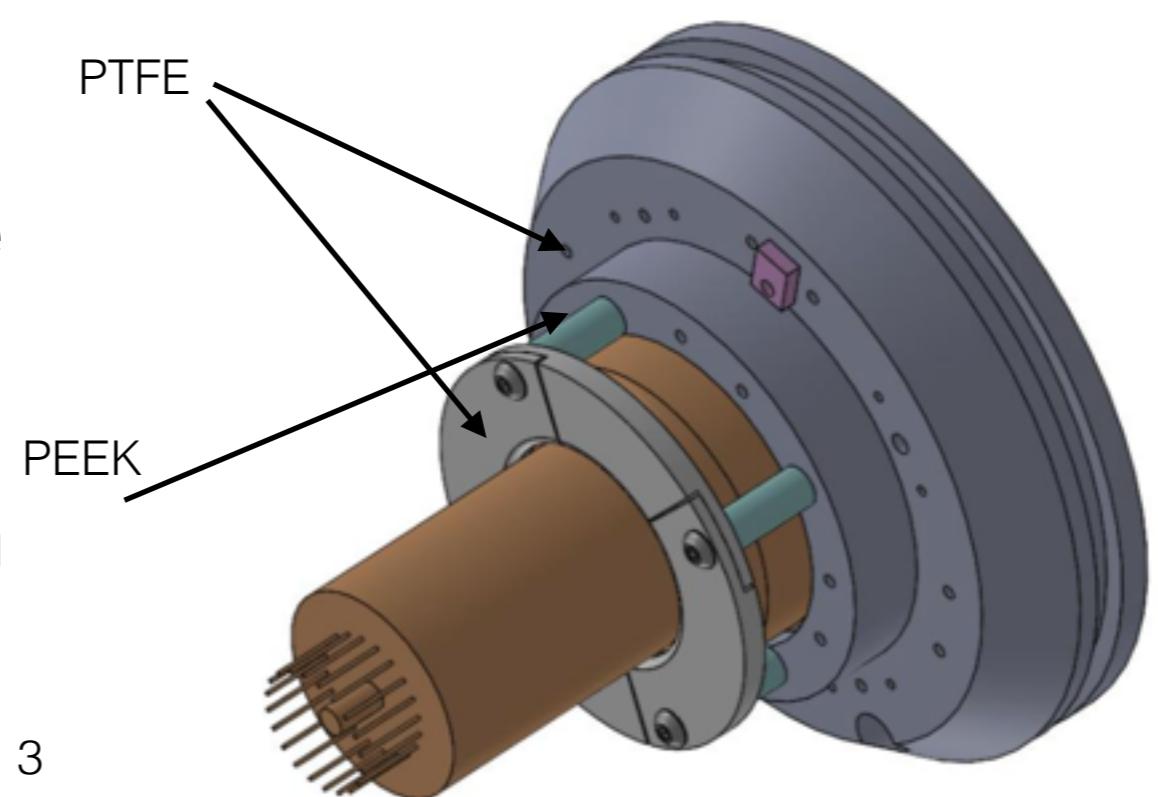
Inspection after run in system test vessel

- Some hints of problems
 - Dent: don't believe it was us, see image of how held in system test vessel
 - Small, 1 mm², white fleck inside PMT that moves as PMT is rotated, seen on side wall, and photocathode, appears to have fallen to back of PMT, no photo taken

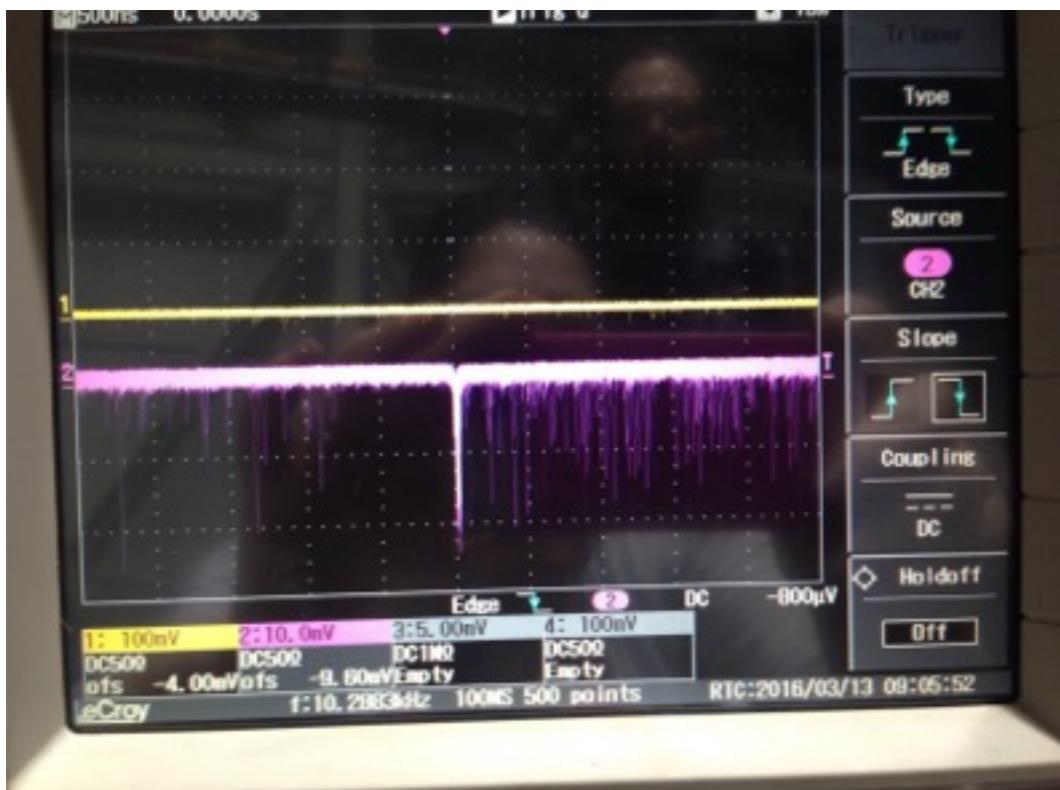
- First ramp up: At first at 1500V and (expected) 16uA but a minute later the current went to 20uA and there were a lot of small photoelectrons.
 - Verified no light leak
- Second ramp up: KB0045 on first, 60 Hz background, ramped up KB0095: 900 V saw triggers matching bigger ones in top PMT, at 1000V things still ok, at 1200 V saw 60 kHz of light in bottom PMT, when switched to triggering on top PMT also saw 60 kHz, took a ~3 min camera image and saw no light though while this was happening. Turned off bottom PMT, top PMT rate dropped back to 600 Hz (had played with threshold a little)

- KB0095 in pink, 10 mV /div. 500 ns/ div, triggering at -800uV, at 1200 V, trade at 10.3 kHz at time of picture
- KB0045 in yellow, at 100 mV/div

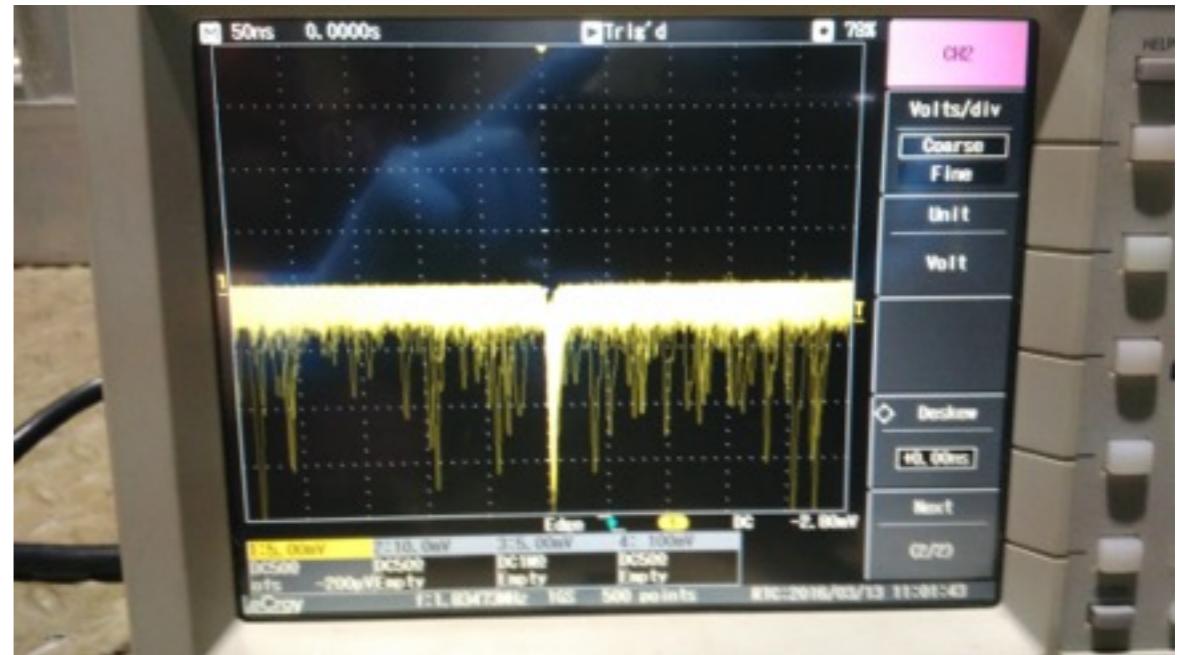
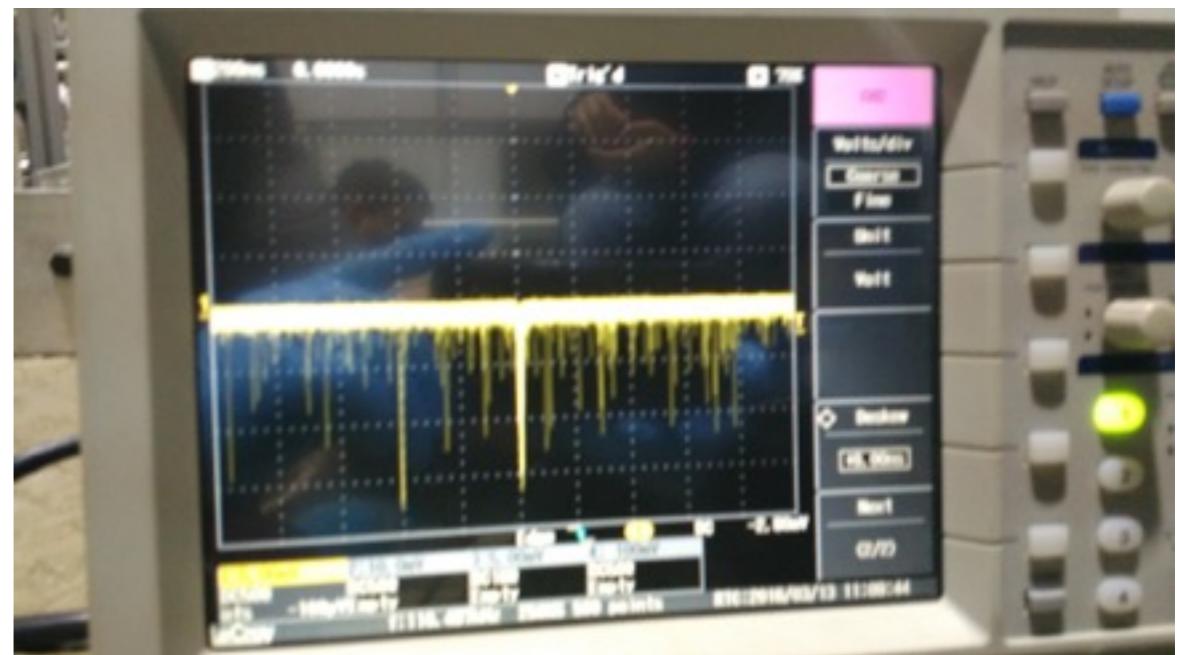
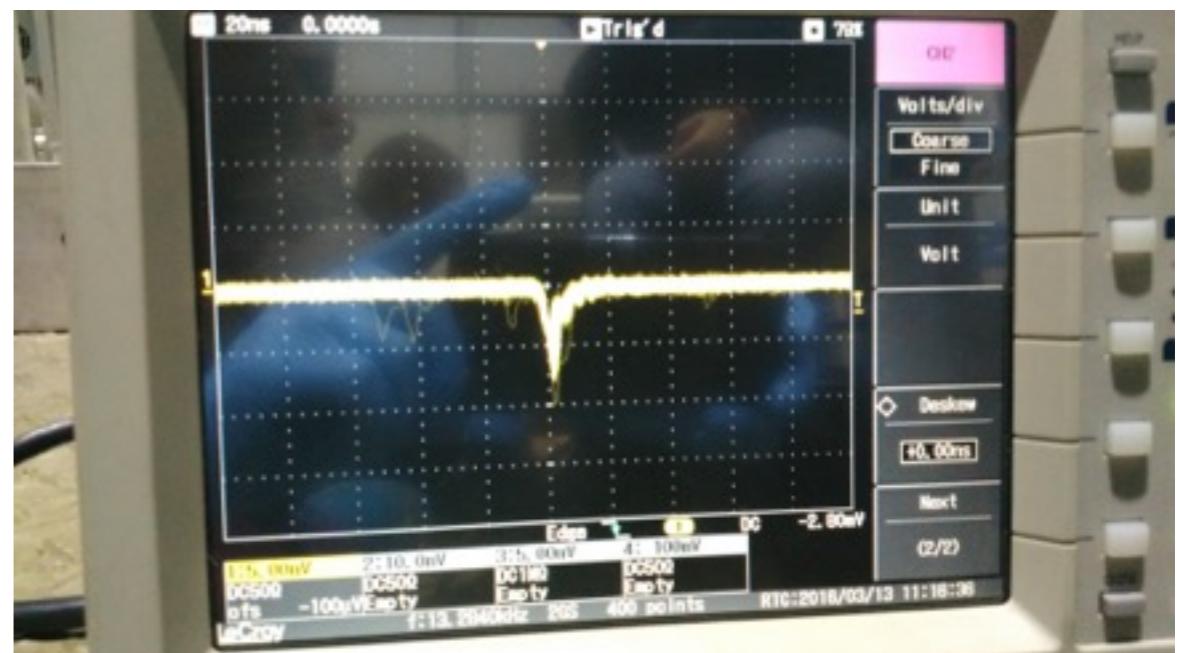
Test in dark box

- More uniform testing: threshold of -2.8 mV, ramp up in 50 V steps
- Test 1: Extra light seen at 1400V (MHz)
- Test 2: Extra light seen at 1200V (100 kHz)
- Test 3: Weird shape at 1450 (13 kHz)

- PMT produces light
- Onset of light and total light production are quite variable
 - Could it be related to the white speck?
- Base tested fine on its own

1. Run with KB0095 anyway - low voltage, ramp down if an issue
2. Run with KB0090 (see later slides) low voltage
3. Run with no bottom PMT
4. Run with old 2" PMT
 1. Exploring this: making a fixture to hold it in place
5. Test PMTs at UCSB to find another good PMT
 1. Kim can drive down with jig and new snips, and base and cables for testing

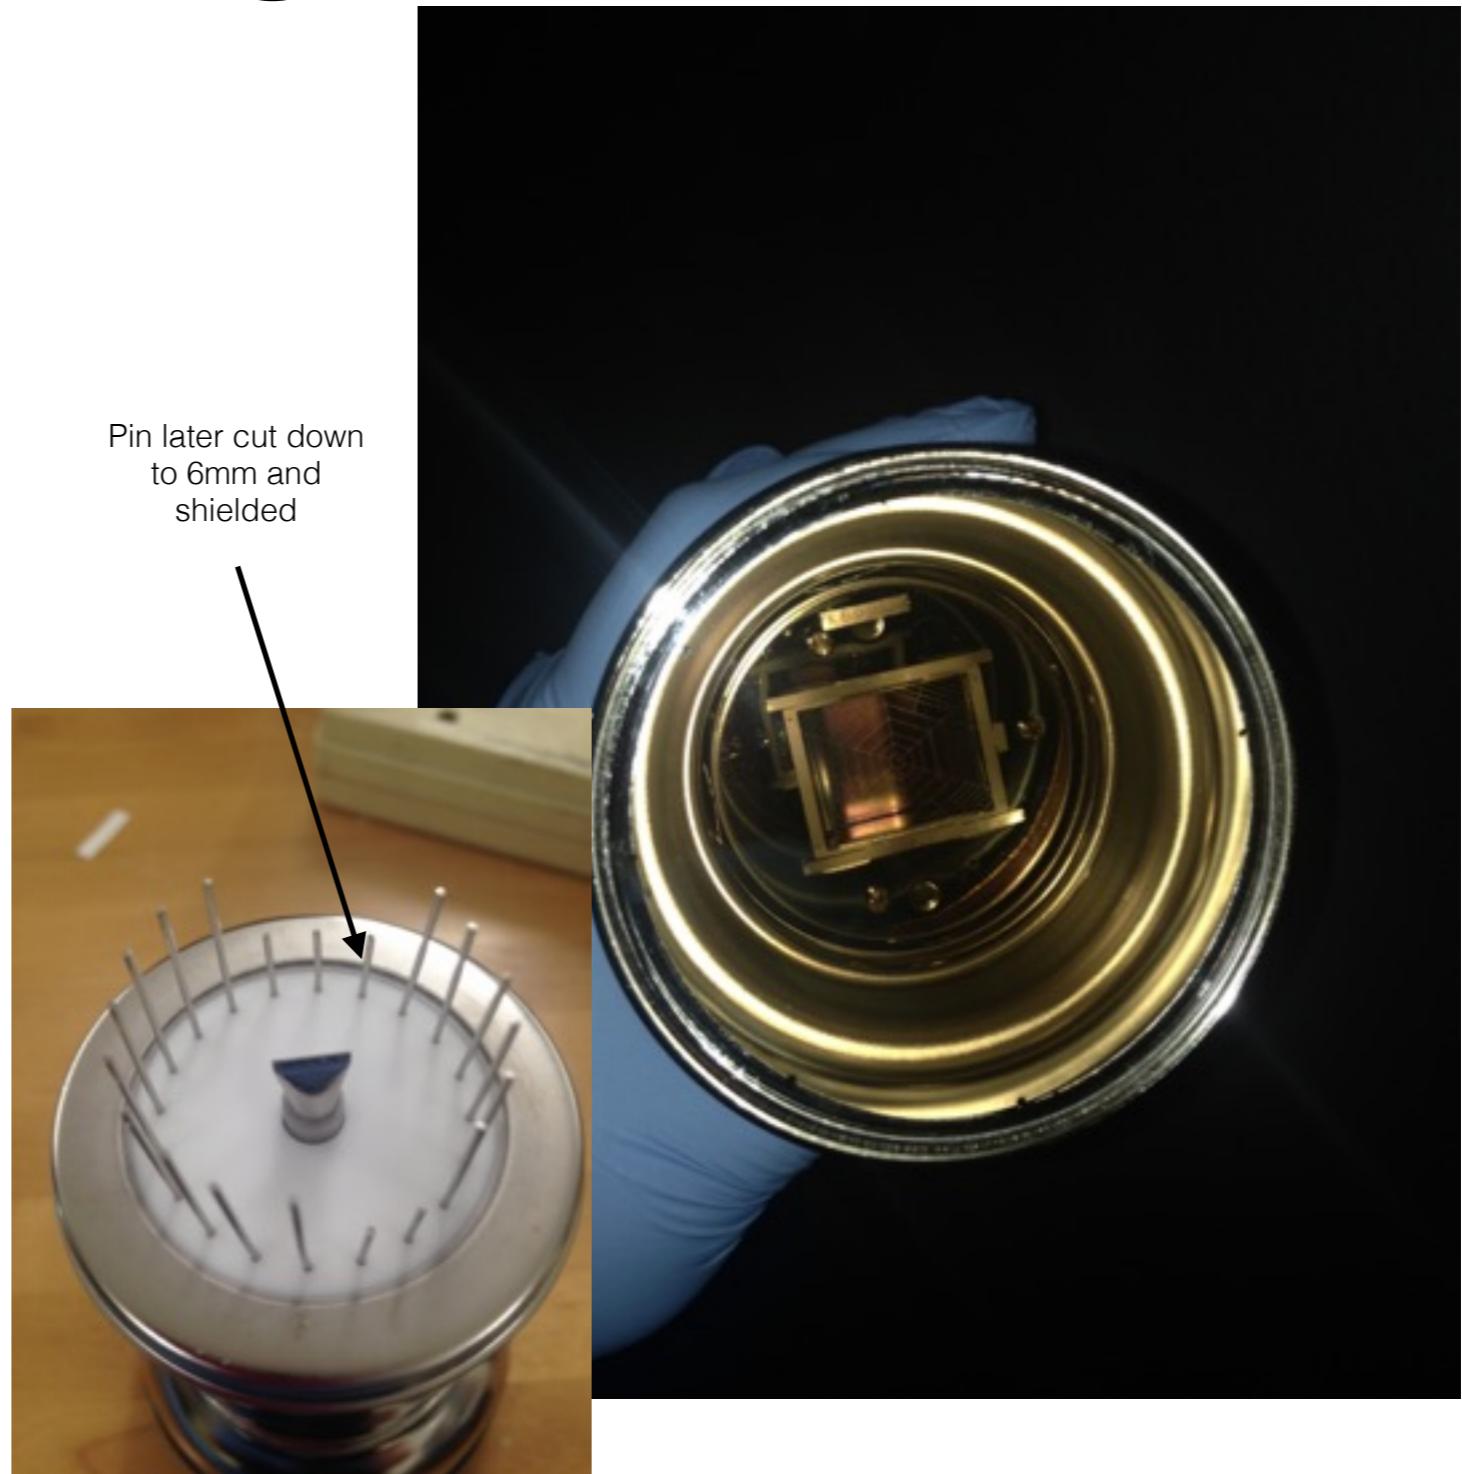
Everything looks ok

- Pins were cut with non-standard technique: only the 5 shortened to miss the base, pliers holding pins still, snips cutting through
- PMT looks fine on inspection

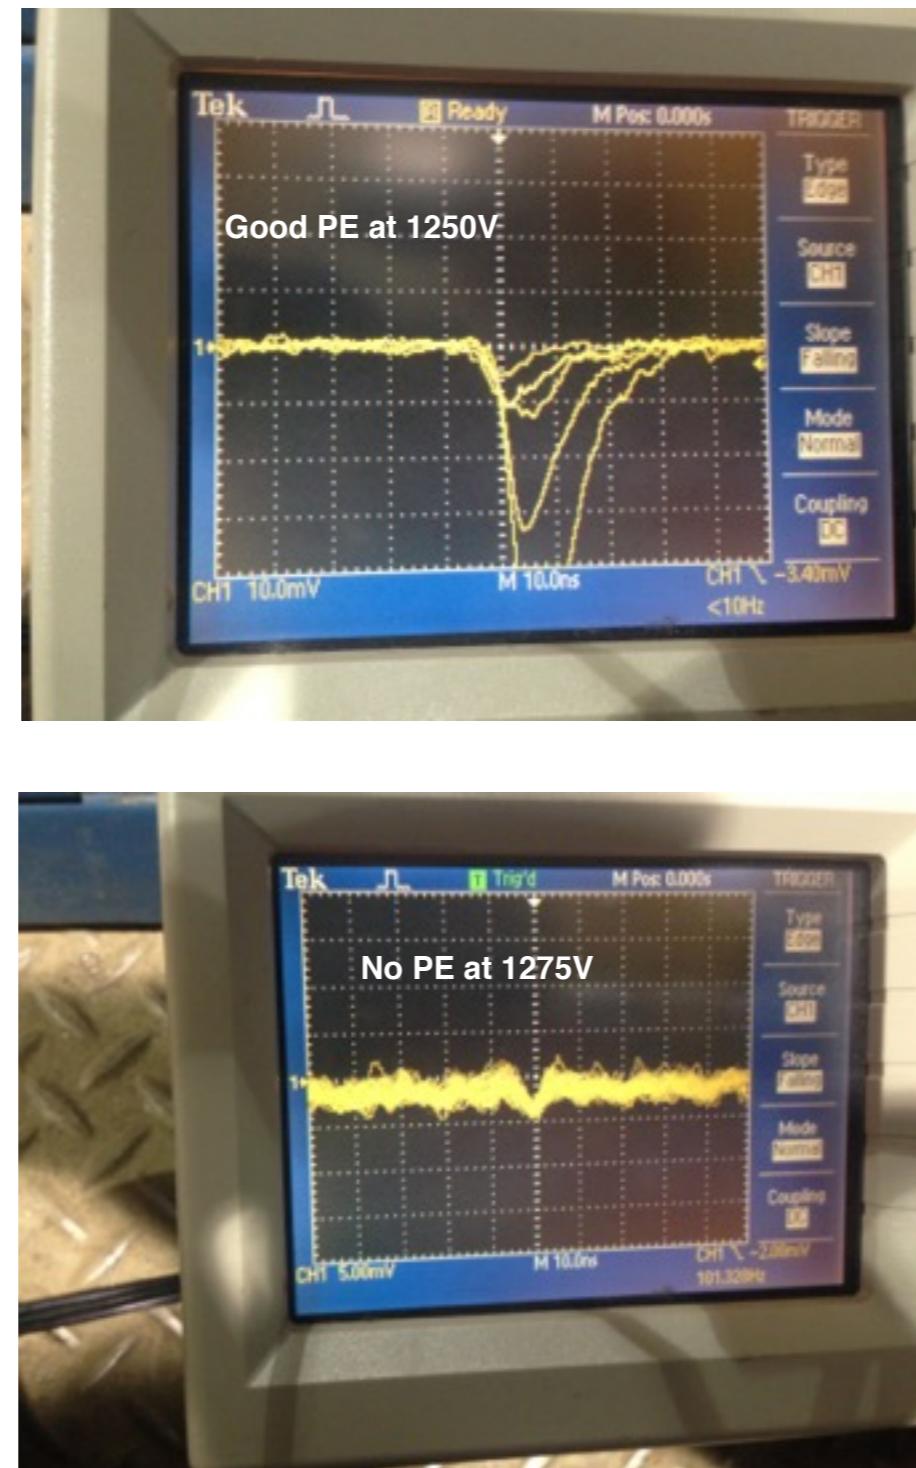
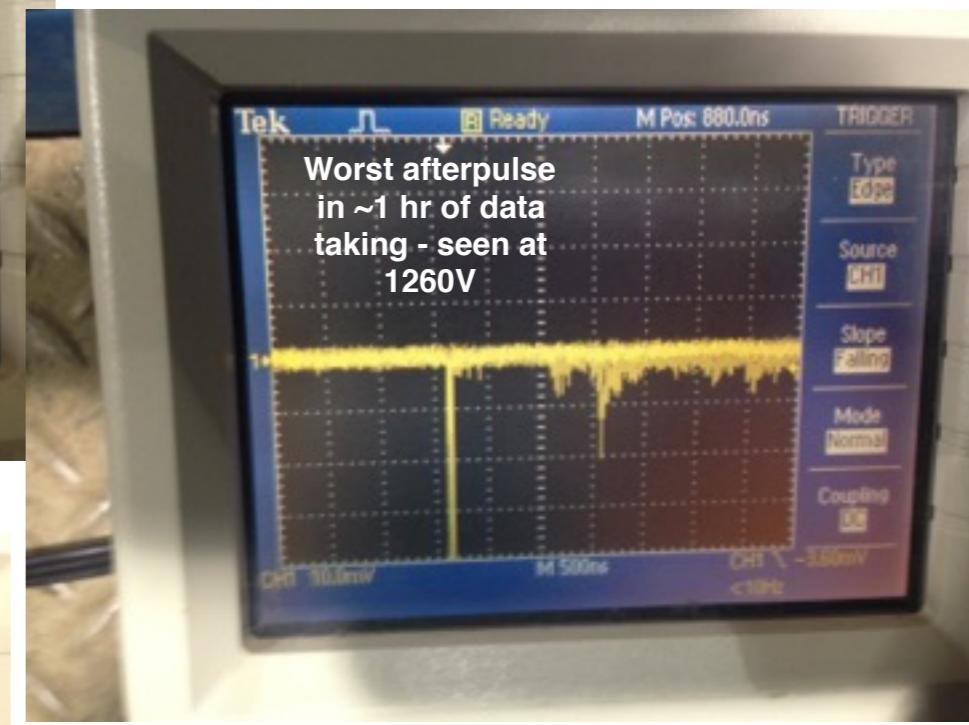
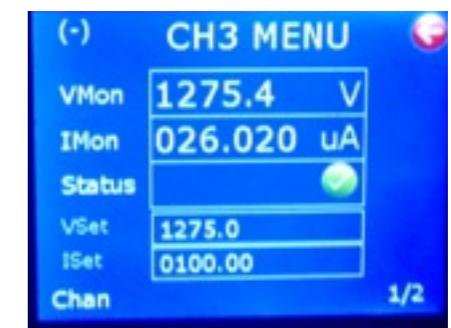
Ramp Up: Stops working

- See some PE ~-1000 V, better at -1200 to -1260
- Very little after pulsing
- Current draw from supply matches Ohms law for 92.4 M Ω base: ~13 μ A at -1250 V
- Abruptly at 1275-1285 (differs by 5 V in different ramp ups) current jumps to double, 26 μ A and stop seeing PE
- Must drop to <500V for current draw to return to normal
