# SLAC Activities Update

Shaun Alsum

LZ Madison Group Meeting

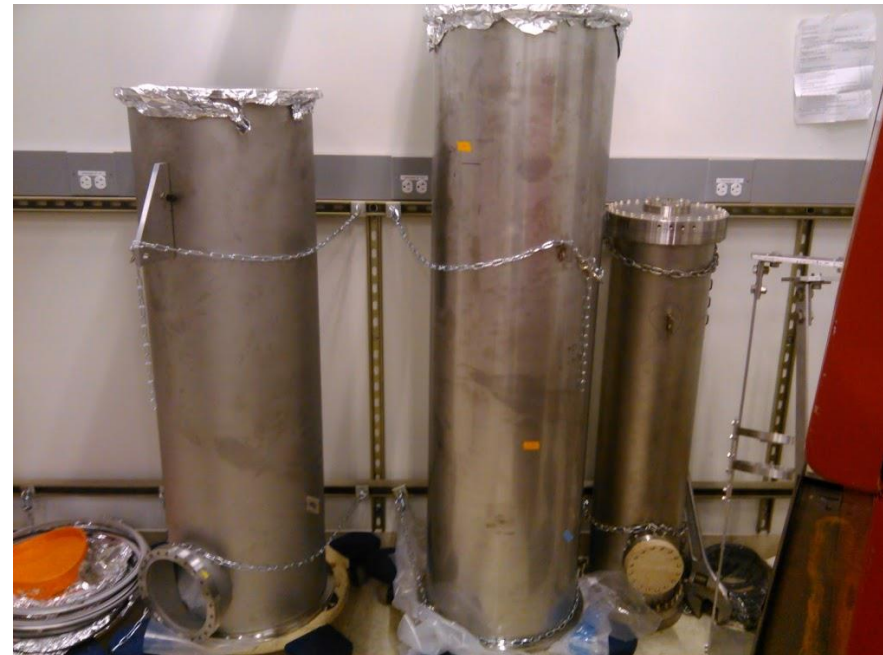
Leftmost: R&D Vacuum vessel. Middle: Purification tower vessel. Right: R&D Xenon Vessel.

- Measured dimensions of T-Slot support structure in order to create plastic sheets to isolate the area as a small clean room.
- Installed the R&D and purification tower vacuum vessels for a pressure test and leak test.
  - Pressure test passed.
  - Leak check was inconclusive, though there may have been a virtual leak, so left pumping over the weekend.
  - Next week discovered the main leak was 2 untightened VCR joints hidden in the back and a lesser leak from one more semi-tightened VCR on the top.

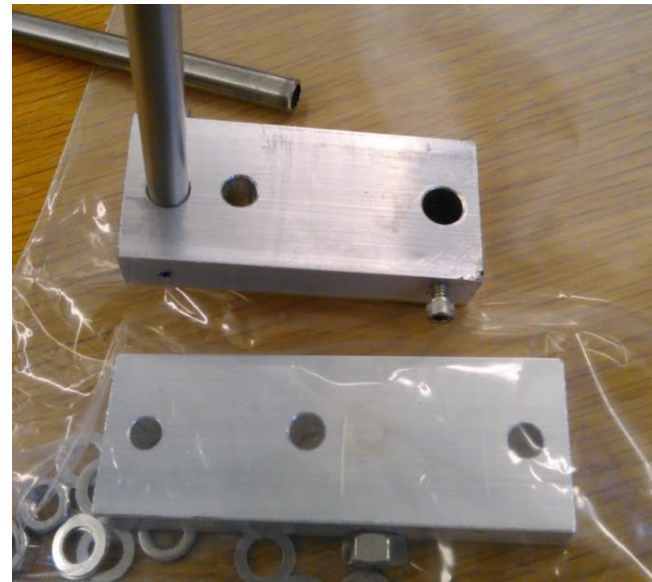
Below: Aluminum blocks for mouning instruments and PMT.

- Hung the top Xenon space flange.
- Removed the vacuum vessels previously attached.
- Re-arranged counter-weight pulleys (still needs some work but much better than before).
- Designed and build aluminum blocks to hang level sensors and the PMT from inside the Xe space.
