Problem with KB0090

Kimberly Palladino

March 2, 2016

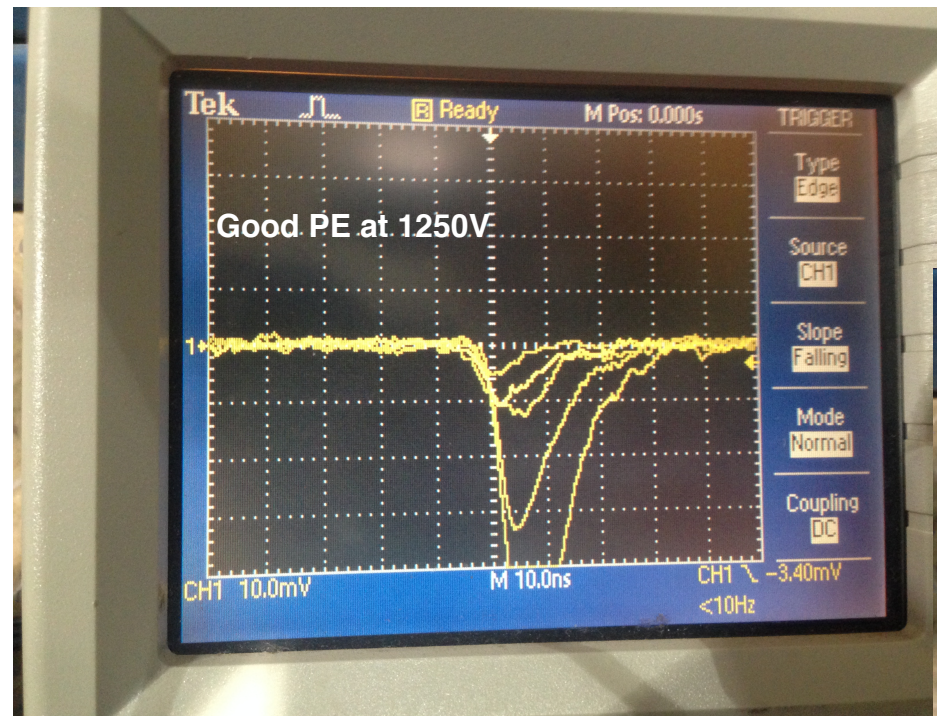
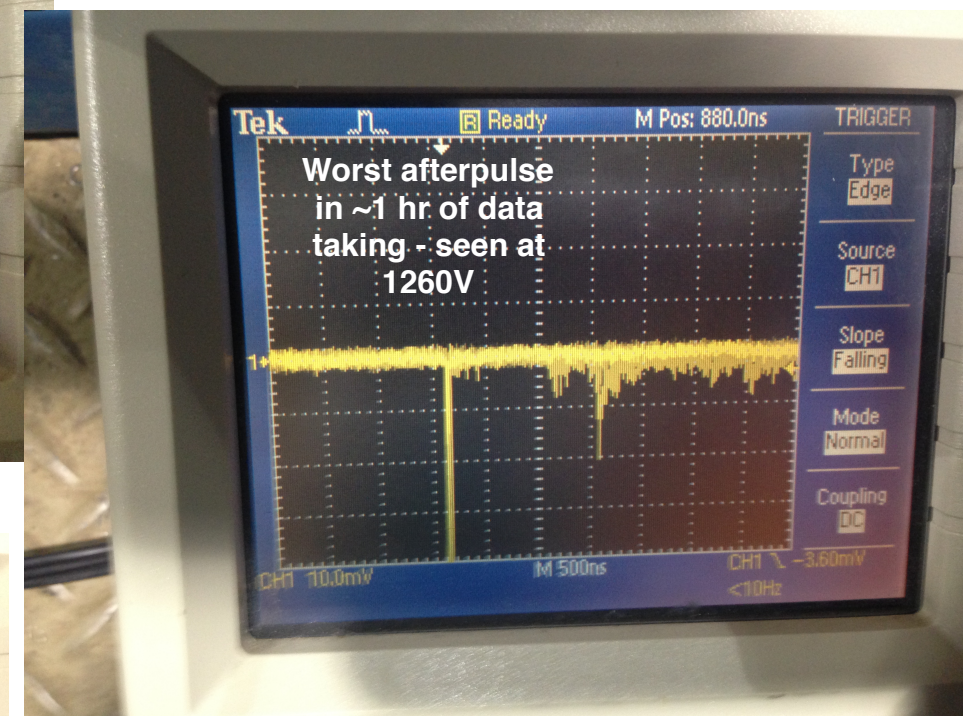
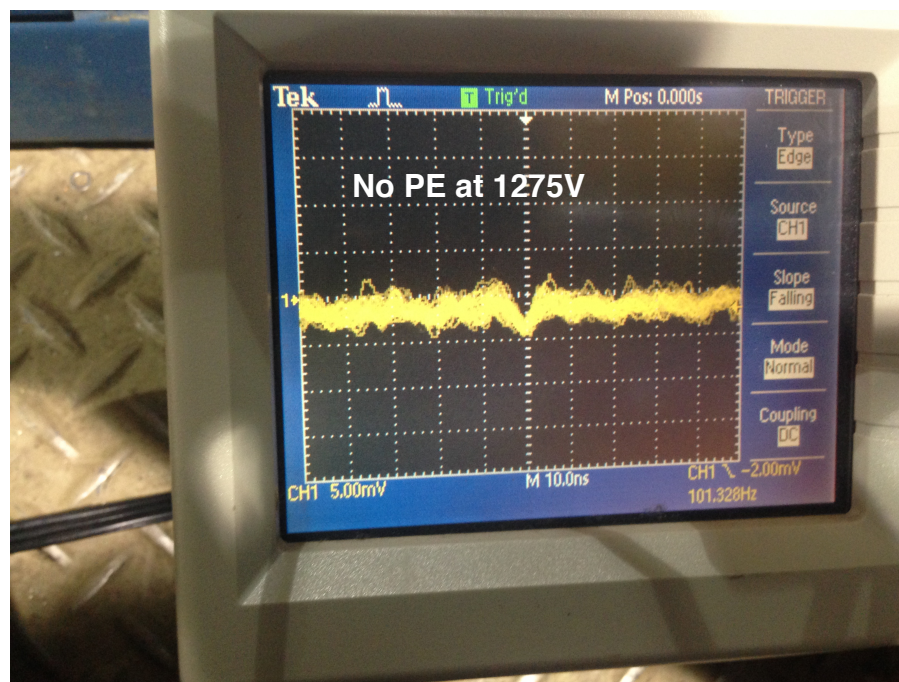
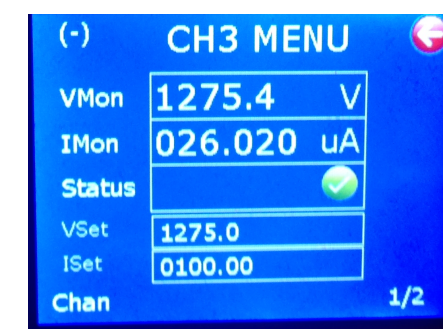
Ramp Up: Stops working

- See some PE ~ -1000 V, better at -1200 to -1260
- Very little after pulsing
- Current draw from supply matches Ohms law for 92.4 M Ω base: ~ 13 μ A at -1250 V
- Abruptly at 1275 - 1285 (differs by 5 V in different ramp ups) current jumps to double, 26 μ A and stop seeing PE
- Must drop to <500 V for current draw to return to normal
