PMT issues encountered at SLAC

Kimberly Palladino
March 12, 2016

New PMT: KB0095

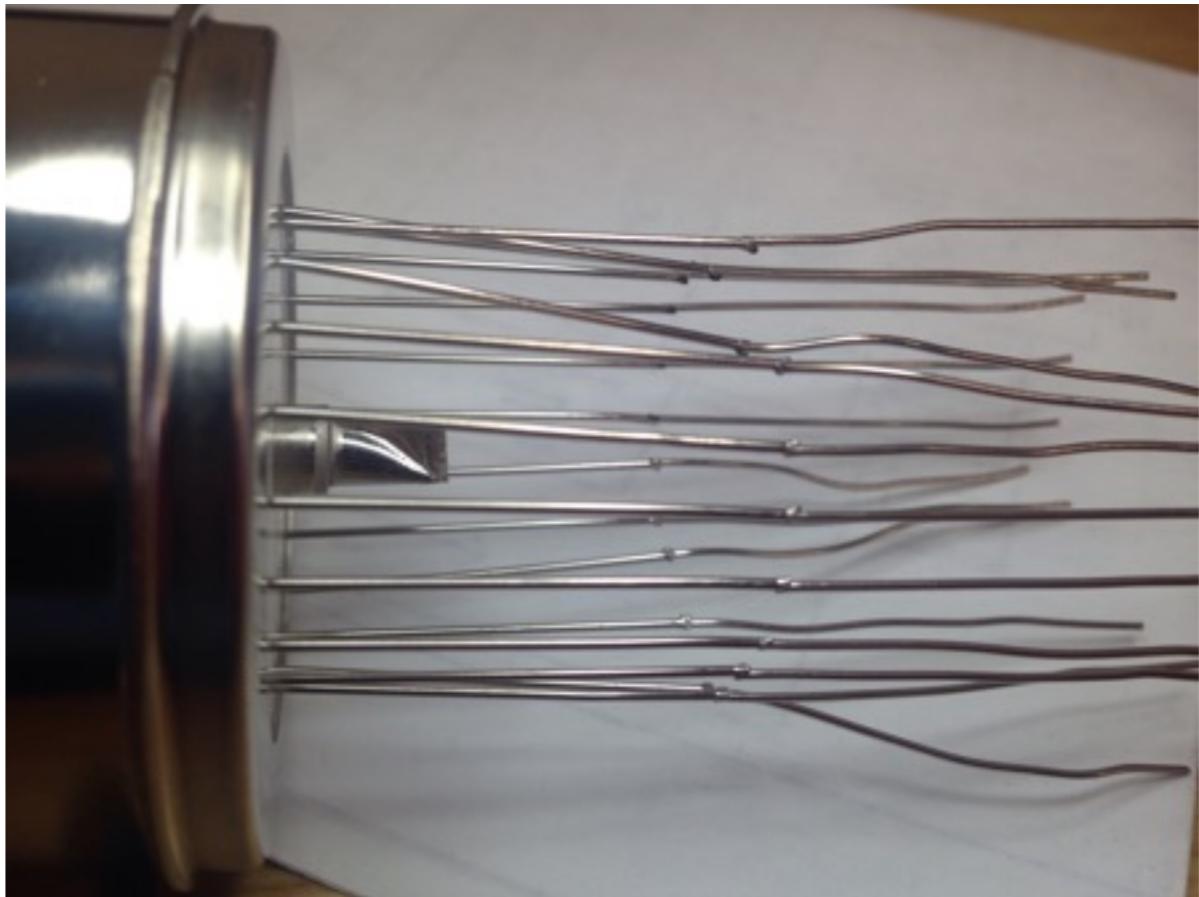
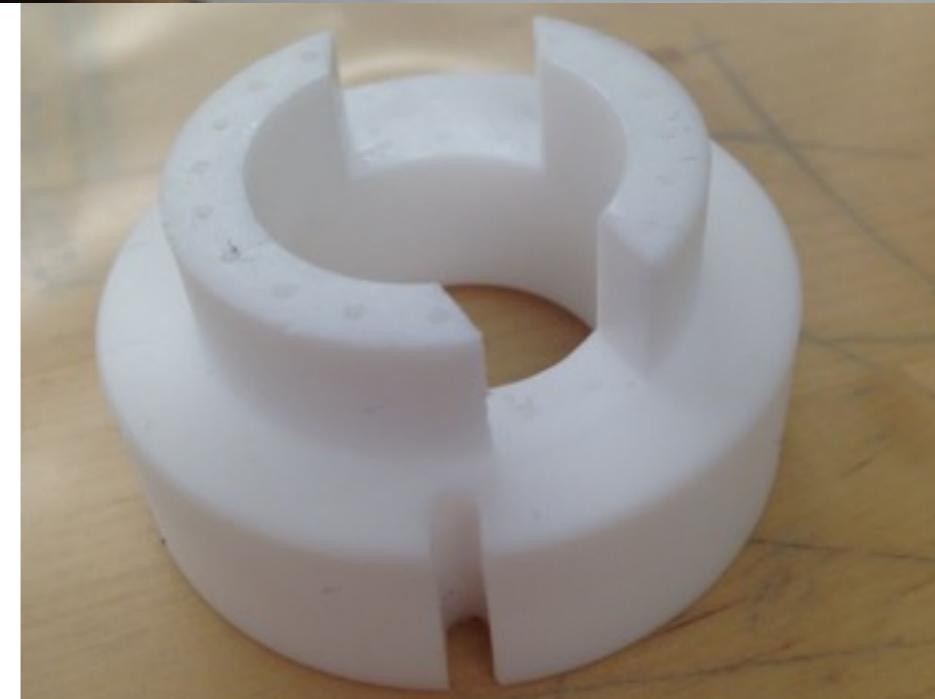
Inspection after run in system test vessel

- Some hints of problems
 - Dent: don't believe it was us, see image of how held in system test vessel
 - Small, 1 mm², white fleck inside PMT that moves as PMT is rotated, seen on side wall, and photocathode, appears to have fallen to back of PMT, no photo taken
